**TEN YEAR PERFORMANCE EVALUATION OF UNBONDED
CONCRETE OVERLAY AND JOINTED PLAIN CONCRETE
PAVEMENT: A TORONTO CASE STUDY**

Paper prepared for presentation at the
“Urban Pavements - Better, Safer, Faster” session
of the 2013 Conference of the
Transportation Association of Canada
Winnipeg, Manitoba

This paper presents an overview of the existing conditions, design, construction and instrumentation of the Bloor and Aukland site and a ten year performance evaluation of the rehabilitated pavements.

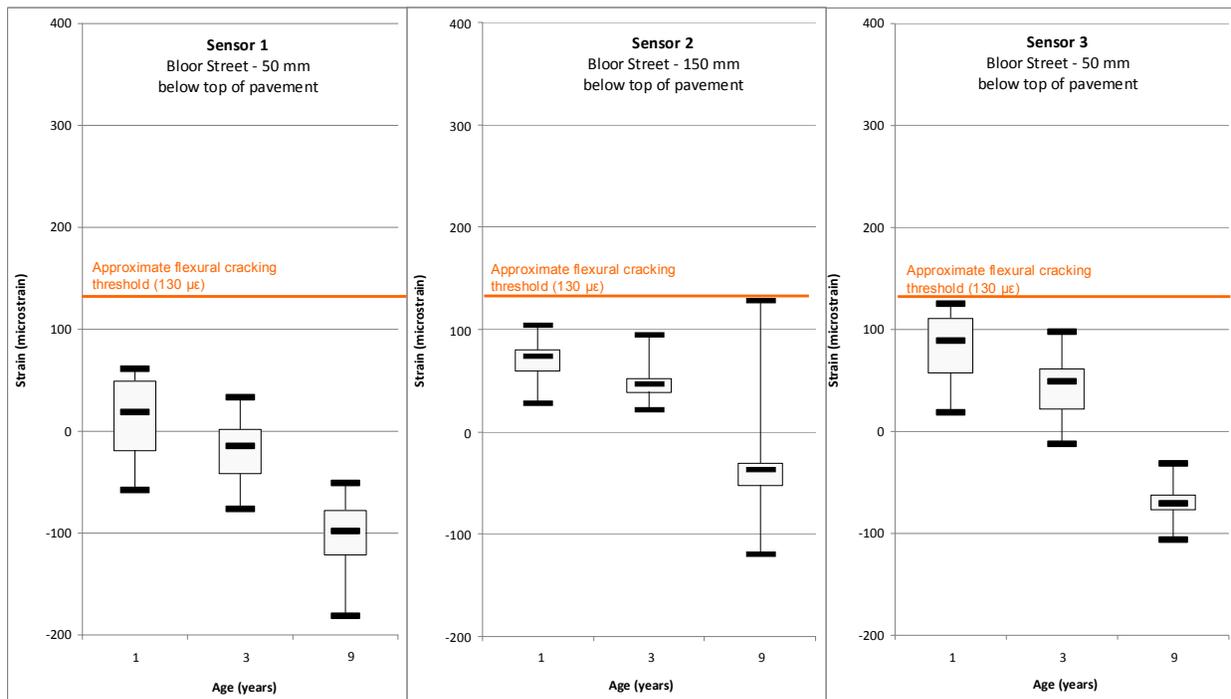
Throughout the ten year period, a general trend of increasing compressive strains has been observed in the unbonded overlay on Bloor Street, both at the top and bottom of the overlay layer. This trend is illustrated in Figure 5, which compares strain data from the first, third and ninth years of service. The boxplots present the maximum, third quartile, median, first quartile and minimum strain values for each year. Strain values greater than zero are tensile; those less than zero are compressive.

The trend of increasing compression at the top surface is no surprise; however, the bottom sensors are expected to be measuring tensile strains. Unbonded overlays are designed to have the overlay slab and existing slab bend separately under traffic and environmental loads due to the placement of a separation layer, shown in Figure 6.

FIGURE 5 Comparison of strains in unbonded overlay after 1, 3 and 9 years of service.

However, preventing a bond between the two concrete layers cannot always be accomplished. It is possible that this may be the case with the Bloor Street overlay. The evidence of compressive strains throughout the thickness of the overlay may indicate that both slabs (old and new) are behaving monolithically and that the neutral axis falls in the old slab. The bonding of the layers can add additional structural capacity to the pavement, but is generally undesirable because it may allow reflective cracking to occur (6). By and large, the strains measured in the overlay section remain fairly low, i.e. well below cracking thresholds. The threshold for flexural (tensile) crack formation in a 30 MPa concrete is approximately 130 microstrain (12). Consequently, considerable remaining pavement service life is expected.

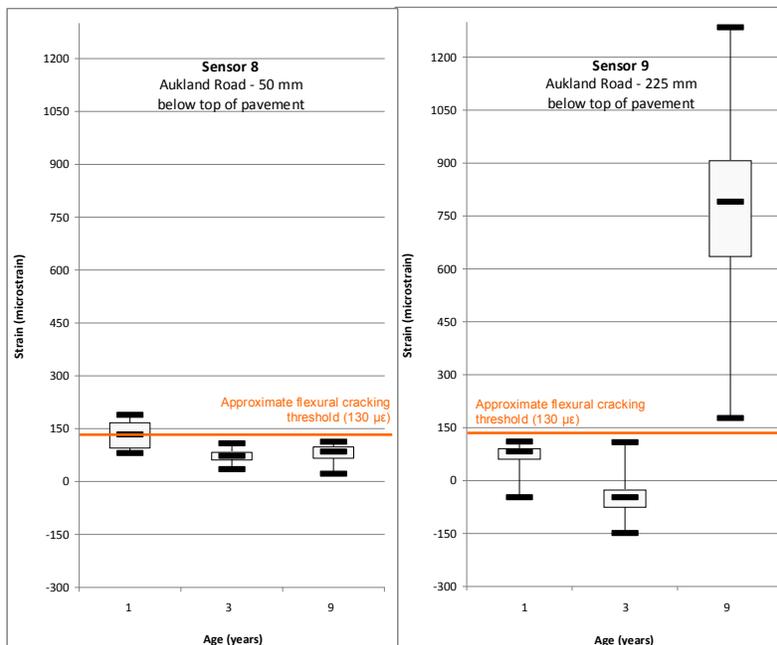
In the Jointed Plain Concrete Pavement (JPCP) section on Auckland Road, the average strain reading for sensor eight (southbound lane, top of concrete) saw a slight decrease between years one and three, and remained fairly consistent through the ninth year of service, not showing much change over time, as seen in the boxplots in Figure 7. The same trend of decreasing strain was observed in sensor nine (southbound lane, bottom of concrete) between years one and three. However, between years three and nine, a significant increase in strain, that is a growth in tensile strains, was observed, also seen Figure 7. The increase in tensile strains is expected at the bottom of the slab as vehicular loads will induce tensile stresses and the damage accumulates with repeated loadings. However, the year nine strain magnitudes are somewhat suspect since they are very high.

Strains of this magnitude exceed the tensile cracking limit of concrete and would have likely resulted in the development of cracking on the surface. However, no distress is visible in the vicinity of the sensor. The probable explanation is the degradation of the sensor over time or damage to the sensor or its wiring. The development of zero drift is also a possible source of error. Zero drift is a condition where the measured strain values changes for reasons other than actual changes in strain, such as creep of the vibrating wire (13). Nevertheless, the trend in strain observed in sensor nine is still valid and overall, the changes in strain observed in the JPCP section satisfy expected trends.

FIGURE 7 Comparison of strains in JPCP after 1, 3 and 9 years of service.

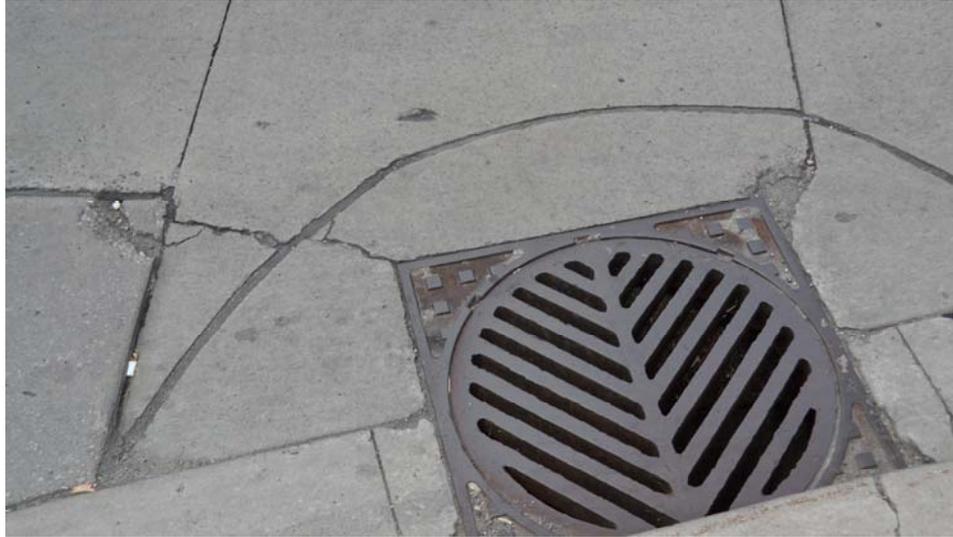
Some transverse joints exhibit ravelling and minor spalling. The longitudinal joints between the pavement and curb and gutter also display occasional spalling as well, likely attributable to edge restraint effects. The settlement and movement of catchbasins has resulted in some cracking in the adjacent concrete, as shown in Figure 8. The improved isolation of the drainage appurtenances could reduce or prevent this damage. The most significant distress is two cracked slabs near the north-south crosswalk on the east side of the intersection, seen in Figure 9.

FIGURE 8 Cracking near catchbasin.

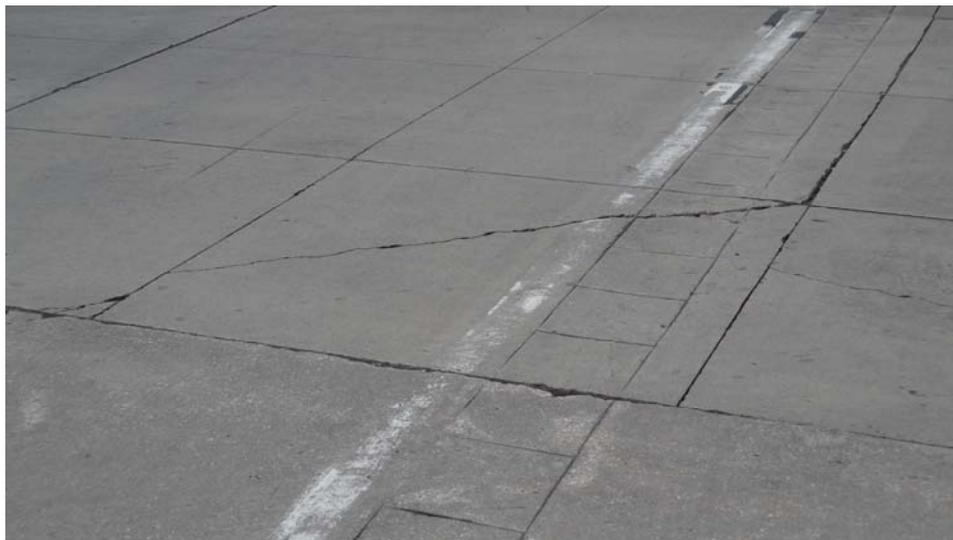
FIGURE 9 Cracked slabs in crosswalk area.
