# **Evaluating Unbonded Concrete Overlay for Usage on Ontario Residential Streets**

A thesis  
presented to the University of Waterloo  
in fulfillment of the  
thesis requirement for the degree of  
Master of Applied Science  
in  
Civil Engineering

Waterloo, Ontario, Canada, 2018

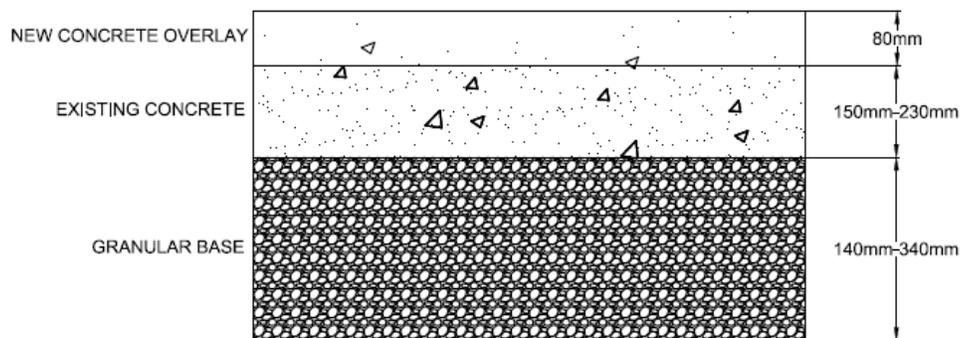
Figure 1-1 Bonded Concrete Overlay (Wafa, et al., 2017)

Bonded overlay is successful when the underlying pavement has been cleaned and has grooves. Paving should begin immediately after cleaning to prevent any dust or debris in-between layers. If properly bonded, the layers will act monolithically, consequently, the bonded overlay can be thinner than an unbonded overlay. If the underlying pavement is PCC, then the joints on the bonded overlay must be matched exactly, otherwise, reflective cracking will immediately propagate to the overlay (Harrington, et al., 2014), Figure 1-1 below shows a typical bonded overlay.

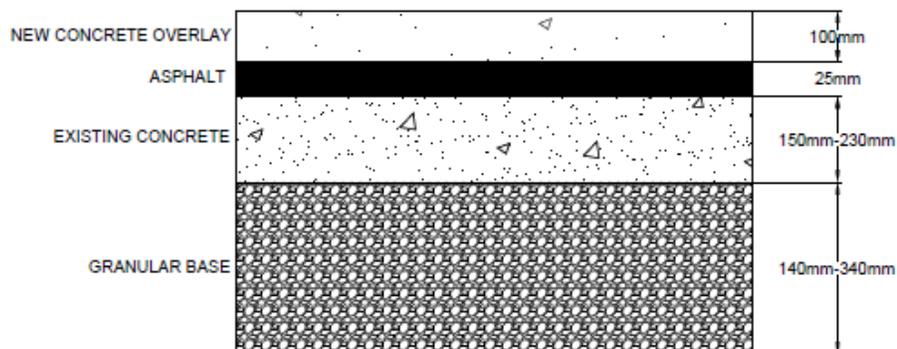
Figure 1-2 Unbonded Concrete Overlay with HMA (Wafa, et al., 2017)

If severe faulting is observed in the concrete layer, a geotextile layer can be used to separate the existing layer with the new layer. The underlying layer should still be cleaned and cold patches should be placed to even the surface layer (Harrington, et al., 2014). Since a separation layer is used in-between, the jointing of the overlay is not required to match the joints of the underlying concrete. Figure 1-2 below shows a typical unbonded concrete overlay with HMA separation layer. The cross section of an unbonded overlay uses HMA as the separation layer, whereas Figure 1-3 displays a cross section with geotextile.

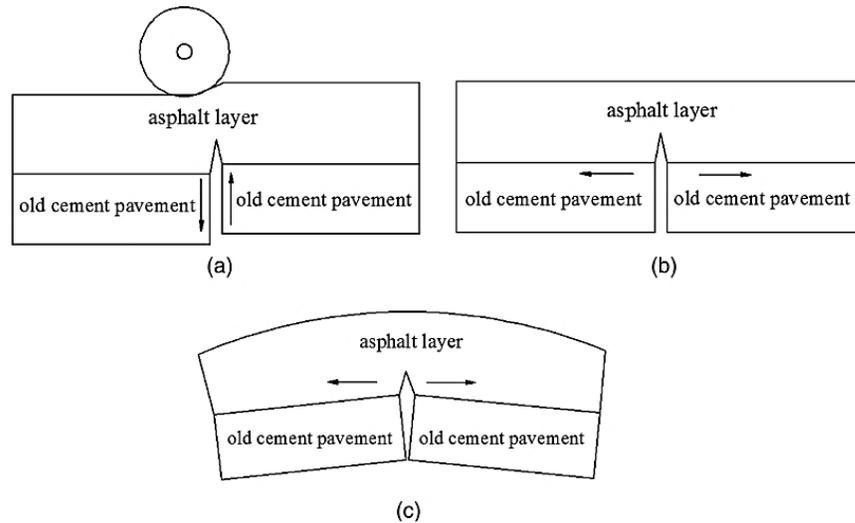
**Figure 2-1 Causes of reflective cracks in a composite pavement (Liu, et al., 2016)**

Figure 2-1 displays the three main causes of reflective cracking, a) is shear stress due to traffic loading, b) is expansion and contraction due to temperature changes and c) is bending and stretching due to slab warping (Liu, et al., 2016).

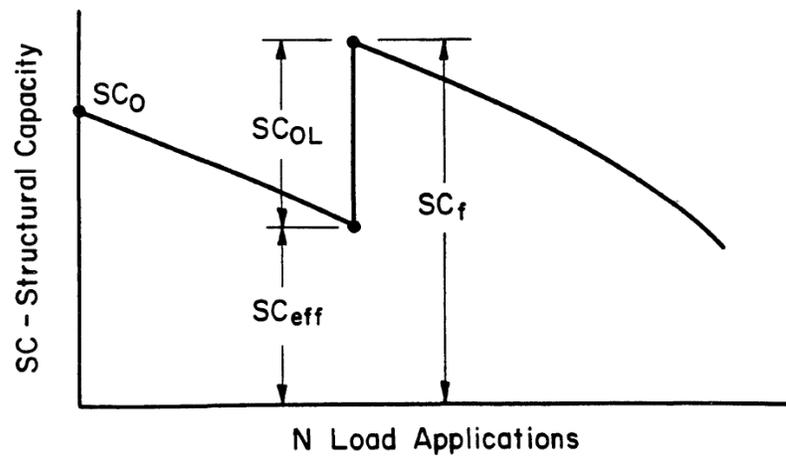
Figure 2-2 Illustration of structural capacity loss over time and with traffic (AASHTO, 1993)

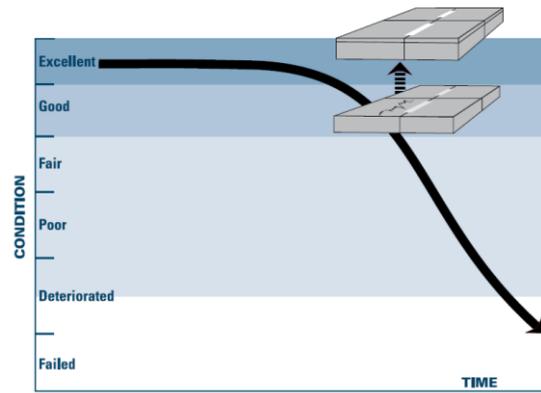
**Figure 2-3 Bonded concrete overlay on concrete (Harrington, et al., 2014)**

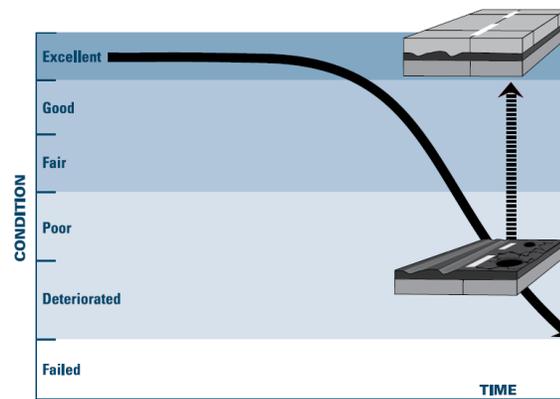
Figure 2-4 Unbonded concrete overlay on composite (Harrington, et al., 2014)

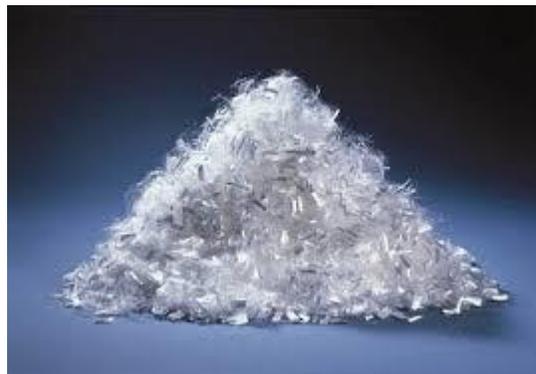
**Figure 2-5 Polypropylene fibres (CEMEX UK Materials Ltd)**

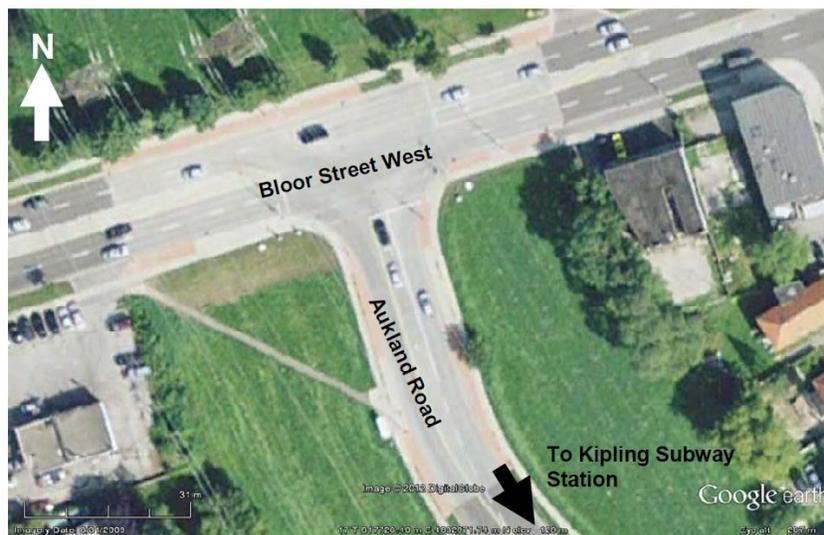
**Figure 2-6 Bloor St. W and Auckland Road Intersection – City of Toronto (Kivi, et al., 2013)**

Vibrating wire strain gauges were embedded in the concrete to monitor the performance of the overlay. The gauges were embedded at various heights and locations along Bloor St. W and Auckland Rd, seven were installed on Bloor St. and five on Auckland Road. The intent of this was to monitor the change in concrete due to environmental and traffic effects. Over the ten-year analysis period, it was found that temperature had the largest impact on the concrete overlay. The largest strain values occurred at higher temperatures while strain decreased as temperatures dropped. In order to validate the concrete overlay design, a key component was monitoring the data and conducting visual surveys every couple of years. A visual inspection conducted in 2013 found the joints to experience minor spalling. Due to the movement and settlement of catchbasins and manholes, some diagonal cracks were visible. Other than that, the street seemed to be in excellent shape with minimal requirement for maintenance.

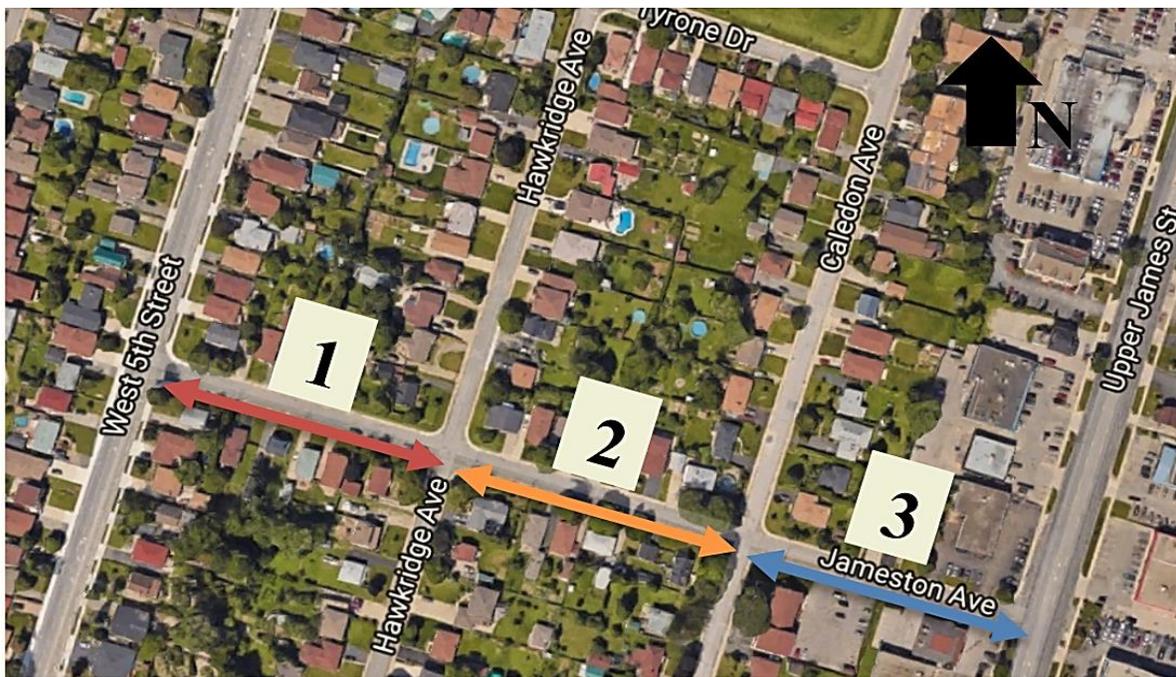
Figure 3-2 Section 1-3, Jameston Ave Satellite Image (Google , 2017)

Jameston Ave. was divided into three sections shown in Figure 3-2, Section 1 is between West 5<sup>th</sup> St. and Hawkridge, Section 2 is between Hawkridge Ave. and Caledon Ave., Section 3 is between Caledon Ave. and Upper James St. Section 1 and 2 mostly comprise of residential homes. A church is located on Section 3 and the driveways to two plazas also exit onto Jameston Ave. as displayed in Figure 3-3. Alexanian Carpet and Floors, a furniture store, is location on the south side of the street, the 2 driveways are used by trucks during deliveries. Goodyear Certified Auto, an automotive shop, has two driveways on the north of Jameston Ave. used by their customers. Finally, the church heavy usage by the community on Sundays.

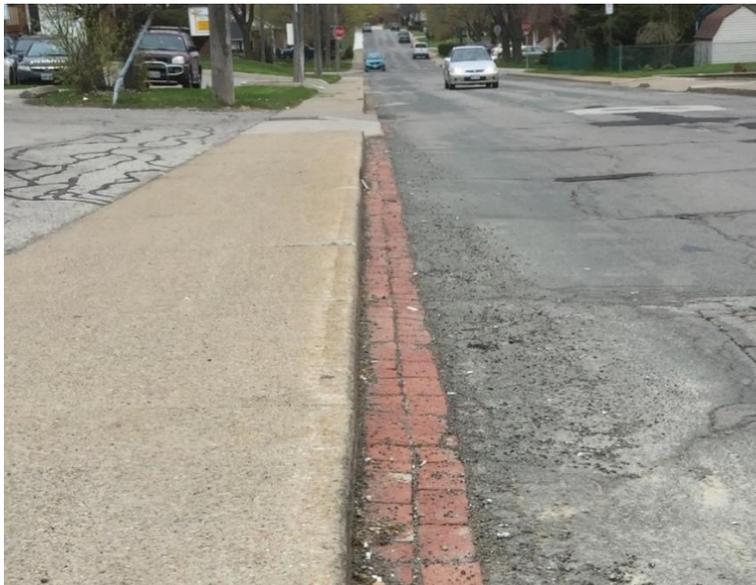
**Figure 3-4 Brick gutter along Jameston Ave. (Pickel, et al., 2016)**

During visual inspection of the composite pavement, Jameston Ave, a distinct design was observed. There were two rows of 100mm wide bricks at the edges of the entire length of the pavement seen in Figure 3-4. The structural intent of these bricks at the time of inspection was not understood. However, similar to interlocking pavers used for drainage, the bricks may have been placed for the same intent. The bricks were not routinely maintained, in many parts of the street, some of the bricks are covered with asphalt, which may have taken place during resurfacing (Pickel, et al., 2016). The surface layer of the road was asphalt with transverse saw cuts all along the road.

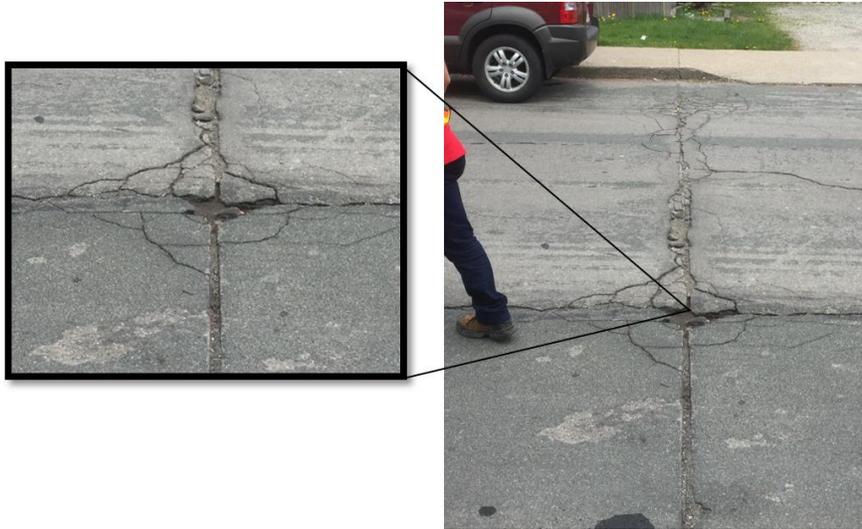
**Figure 3-5 Typical deterioration on transverse saw-cut joints (Pickel, et al., 2016)**

Once the transverse saw-cut joints were identified, the distance between joints were measured, the spacing of the joints was approximately 9.5m. The transverse joints were sealed to prevent bottom-up reflective cracking from the underlying layer. Due to the lack of maintenance, the sealant in the transverse joints had significantly deteriorated. This deterioration caused distresses such as alligator cracks to form from the joints as seen in Figure 3-5. These cracks were seen along the entire street.

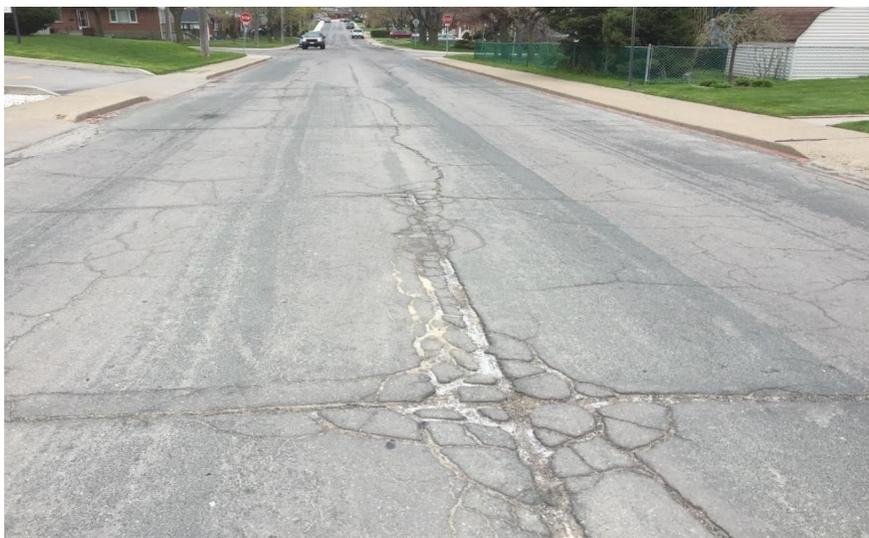
**Figure 3-6 Longitudinal cracks along Jameston Ave. (Pickel, et al., 2016)**

Since the asphalt layer was not longitudinally saw cut to match the underlying layer, this caused longitudinal cracks to develop Figure 3-6. The longitudinal cracks appeared at the center of the street and at 1/3<sup>rd</sup> of the width in some sections (Pickel, et al., 2016). The cracks did not run in a straight line, at certain locations they meandered. At the time of inspection, the cause of the cracks was unknown, they could have resulted from the longitudinal joints or distresses underneath. The deterioration along the street did not necessarily indicate the condition of the underlying pavement.

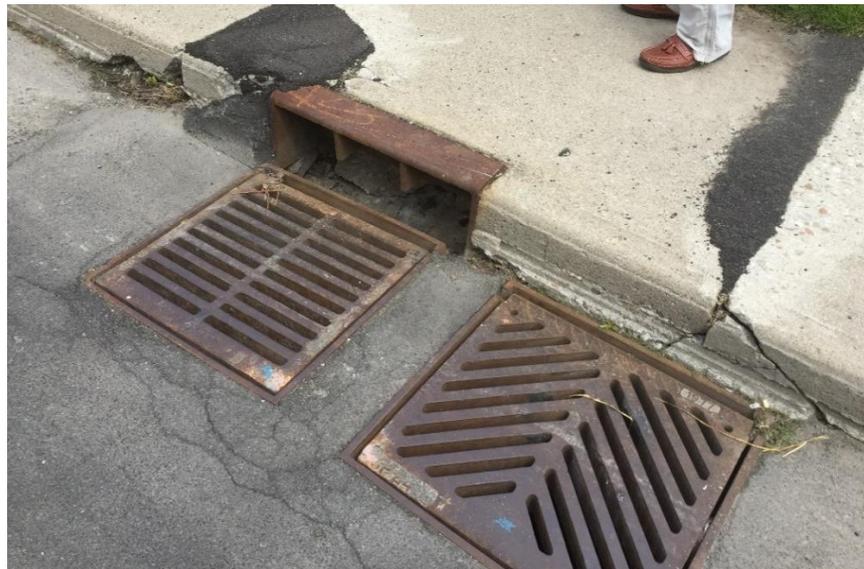
**Figure 3-7 Settled catch basins in Section 2 (Pickel, et al., 2016)**

The catch basins settled overtime and voids were visible through the grating, Figure 3-7. At the time of the visual inspection it was not clear how much damage the underlying concrete experienced. The impact of water to the bondage between each layer was also unknown. The sidewalks along the street were in need of repair, sidewalk distresses in Section 2 were more apparent.

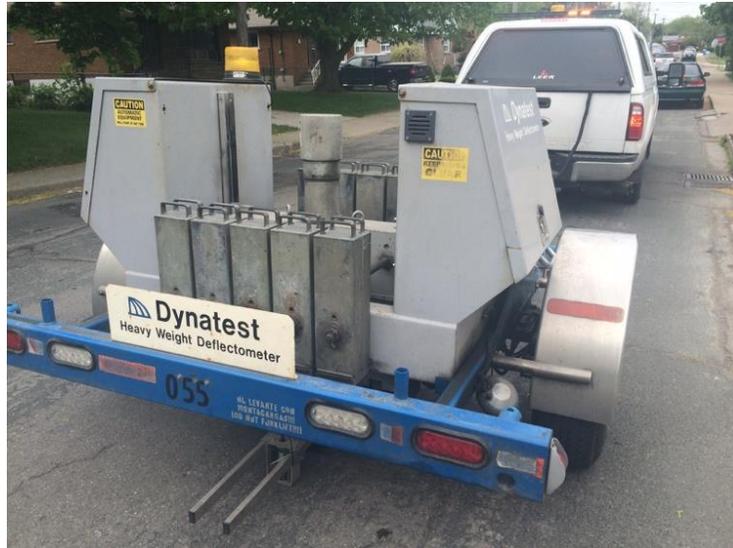
**Figure 3-10 Falling Weight Deflectometer (FWD)**

A seating load of 40 kN was used for the test, the test was conducted on June 2<sup>nd</sup>, 2016 with an average temperature of 20°C. The testing was conducted on 40 separate locations along the street east to west from Upper James St to W 5<sup>th</sup> St and then another 40 locations travelling west to east from W 5<sup>th</sup> St to Upper James St. Three load drops of 40 kN, 55 kN and 70 kN on each pavement location were applied (Stantec Consulting Ltd. , 2016). The 80 test locations were selected randomly along the road, some of them were over distresses such as alligator cracking, while others on good condition pavement. They were conducted in the outer wheel path each of the locations were spray painted and marked with an ‘x’ for identification purposes.

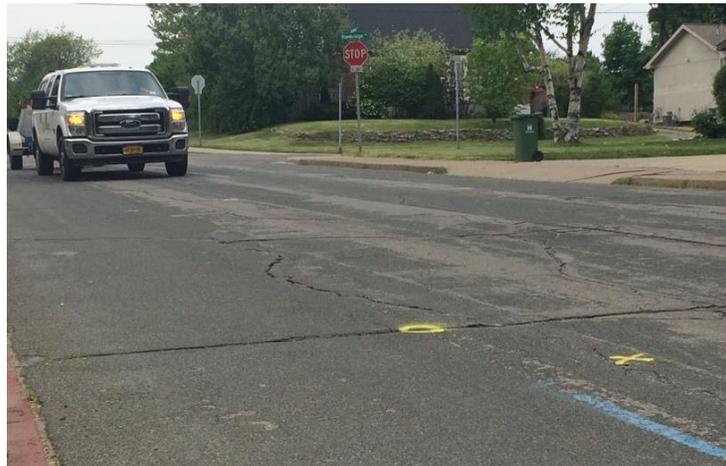
**Figure 3-11 FWD Test marking on Jameston Ave.**

After the testing was conducted at various points along the road, the joints were tested. The vehicle travelled from W 5<sup>th</sup> St towards Upper James St (west to east) and a total of 40 joints were tested, however not all joints along the wheel path were accessible due to parking on both sides of the road. The load was applied adjacent to the joint, marked with an 'o', three drops were loaded to the west and then to the east of the joint seen below Figure 3-11.

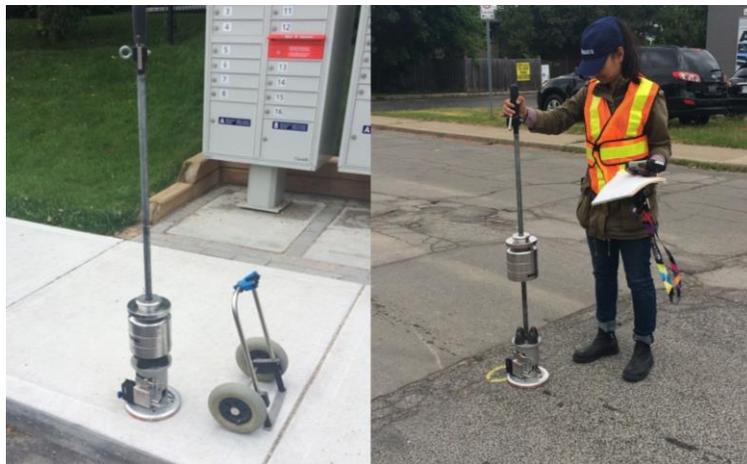
**Figure 3-12 Light Weight Deflectometer (LWD) testing on Jameston Ave.**

A Light Weight Deflectometer (LWD) is a portable Falling Weight Deflectometer and functions similarly to the FWD machine. It is a portable device and can be used to test the subsoil degree of compaction. A release mechanism holds the falling weight at a constant height, the weight drops and transmits the load onto the pavement seen in Figure 3-12. In compliance with health and safety at the University of Waterloo, hard hats were not required during the testing of LWD. The LWD is a manual procedure where human error is introduced, especially if the weight is not dropped properly. The analysis from the testing prior to construction is discussed in the analysis portion, Chapter 5.

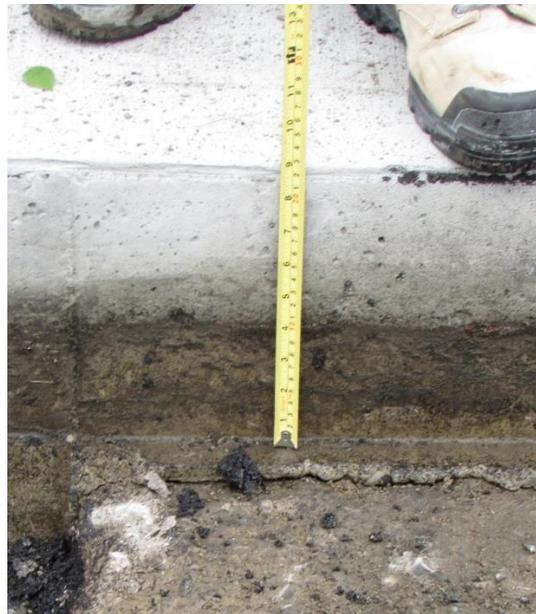
**Figure 4-2 Height from the bottom of existing concrete to top of curb (Section 1) (Pickel, et al., 2016)**

The design for this section was restricted due to the existing sidewalk and curb. The sidewalks and curbs were newly constructed a year before in 2015, removing them would not be economical or environmentally friendly. The concrete base in this section is also thicker than the rest of the street according to the coring report (Peto MacCallum Ltd., 2015). Once the asphalt was milled off, the height from the bottom of the existing concrete base was measured to the top of the curb. As shown in Figure 4-2, the elevation difference was 225mm. In the City of Hamilton's Public Works Department Standard Road Drawings (RD-103) the specified curb height is 150 mm. In order to meet the specified curb height, the concrete overlay could only be a maximum of 75mm (Pickel, et al., 2016). However, the minimum thickness of a concrete overlay according to the Harrington & Fick, 2007 is 100mm. Due to this restriction, it was recommended that a concrete overlay with a thickness of 100mm be used and a geotextile separation layer with a maximum height of 5mm. The City of Hamilton's standard specifications had to be compromised with the curb being 120mm (Pickel, et al., 2016).

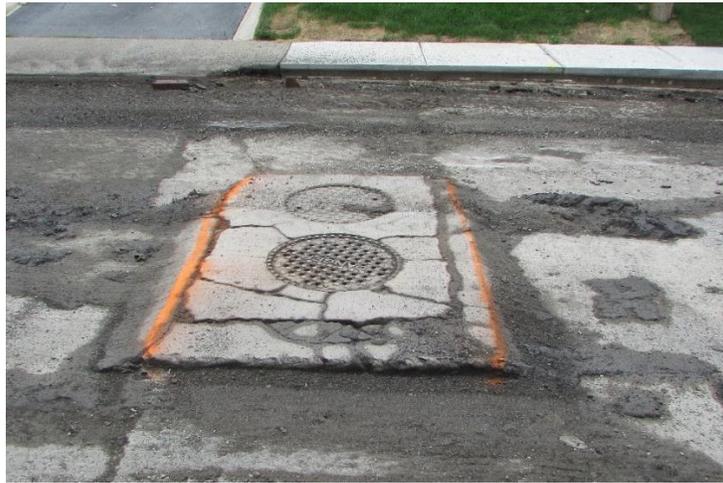
**Figure 4-3 Manhole detail for Section 1 (Pickel, et al., 2016)**

The geotextile thickness was about 3mm and weighed 440 g/m<sup>2</sup> (13 oz/yd<sup>2</sup>) (Pickel, et al., 2016). It was recommended to use a white coloured non-woven geotextile to prevent the pavement from becoming overheated, however only black non-woven geotextile was available. The geotextile was recommended to be placed and secured in place with nails once an even base surface had been achieved through repairs. The section has four catchbasins and two manholes, the isolation joints were designed according to ACPA, 2007. For the two manholes, seen in Figure 4-3 below, a rectangular boxout with joints connecting to the corners of the rectangle.

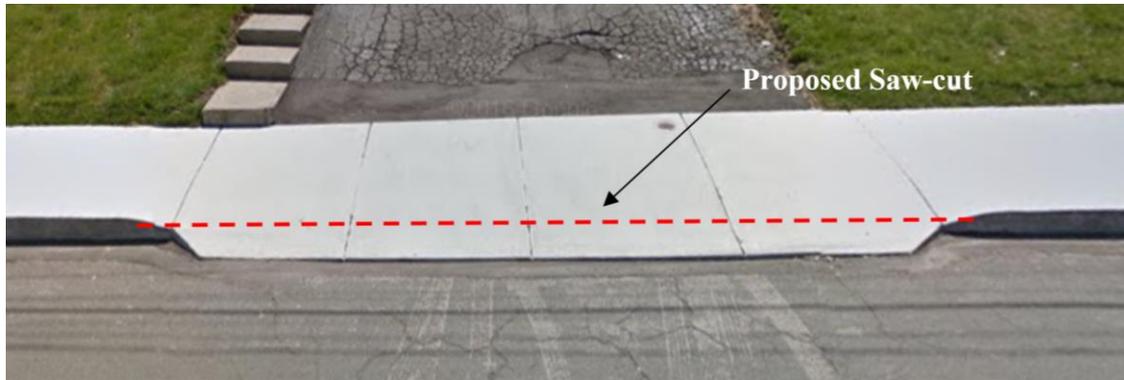
**Figure 4-4 Proposed saw-cut for extended driveways Section 1 (Pickel, et al., 2016)**

The driveways in section one protrude onto the roadway, seen in Figure 4-4. Due to this specific design and elevation limitations, the slope was recommended to be saw-cut flush with the vertical outside face of the curb and the overlay elevation matched to the driveway. However, during construction it was determined that no changes should be made to the driveways and the concrete would be poured to keep the original shape. Although, for the driveways on the north side of Section 1, rubberized material was placed along the edge of the sidewalk to allow for expansion and contraction of concrete.

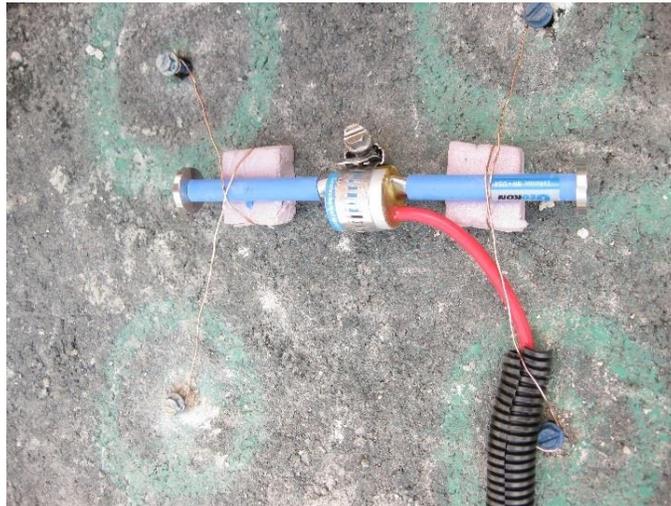
**Figure 4-6 Typical Vibrating Wire Strain Gauge along Jameston Ave.**

2. The wires of the strain gauges were covered in black plastic piping to prevent any damages that may occur during installation on the field. Each sensor was labelled for easier identification during installation.
3. On site, four holes per sensor was drilled, for Section 1, the underlying concrete was drilled, and the geotextile was placed on top and cut to match the holes. For Section 2 and 3, holes were drilled into the asphalt separation layer.
4. Tapcon Concrete Anchors © were placed into the drilled holes and 15mm of Styrofoam was cut into small squares.
5. The Styrofoam was placed underneath the sensors and was fastened with a copper wire and attached to the Tapcon Concrete Anchors ©, Figure 4-6.

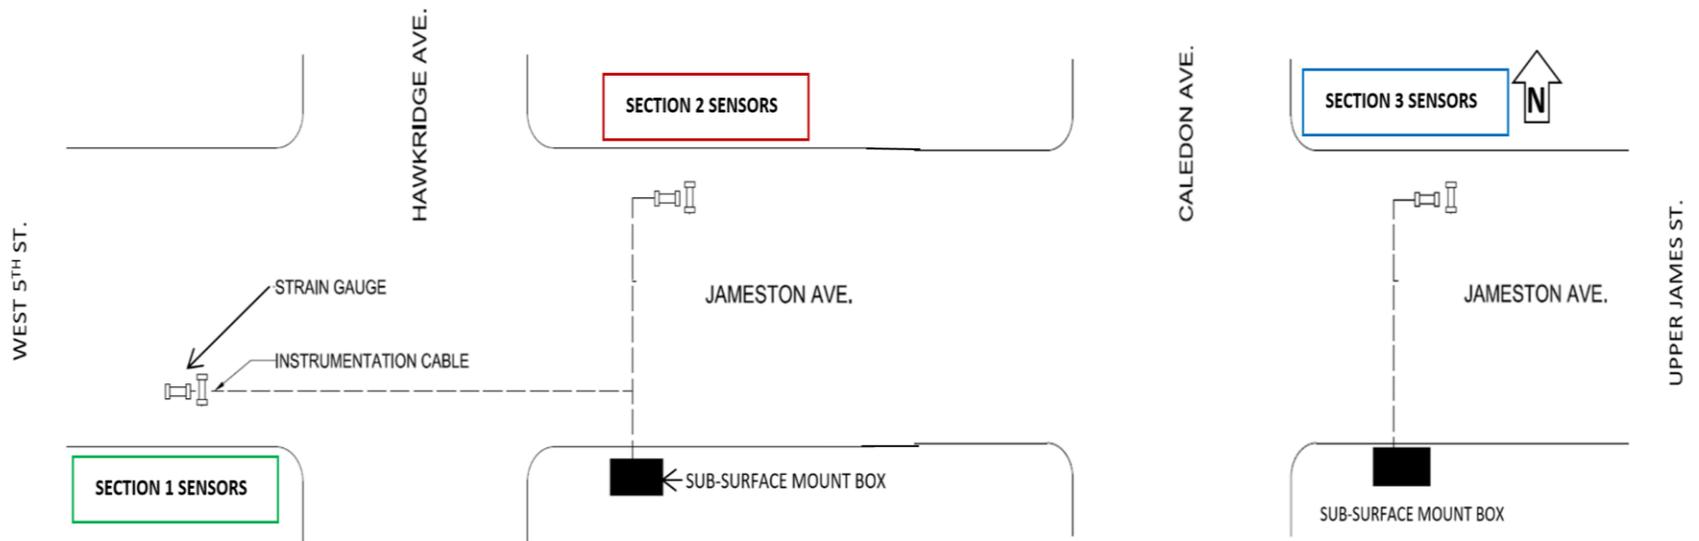
**Figure 4-7 Instrumentation layout on Jameston Ave. (Pickel, et al., 2016)**

The strain gauges were placed on top of Styrofoam to remain at the lowest portion of the concrete overlay. It was also done due to the overlays not having any reinforcement, this method allowed the concrete to remain embedded in concrete intact without touching the separation layer. During paving it was crucial to ensure the instrumentation does not get damaged during paving, or get moved due to any strong forces. In coordination with the contractor the sensors were placed directly in front of the paver. The encased cables were run across the street through the PVC pipes installed underneath the sidewalk towards the sub-surface mount box. The sensors were covered with a small amount of fresh concrete before the paver went over to prevent any damages, seen in Figure 4-8.

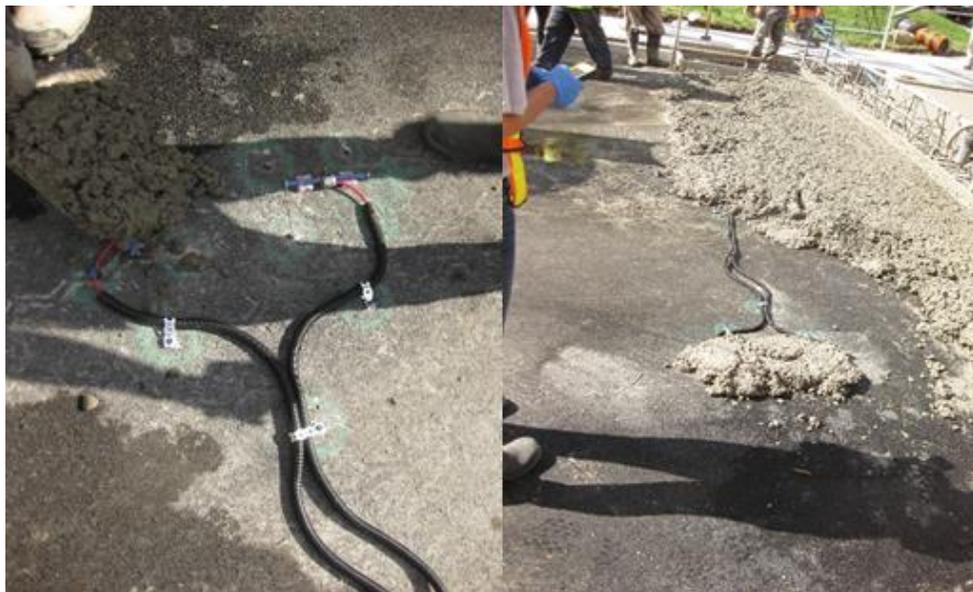
**Figure 4-8 Typical sensors being covered using fresh concrete and cable running across the street**

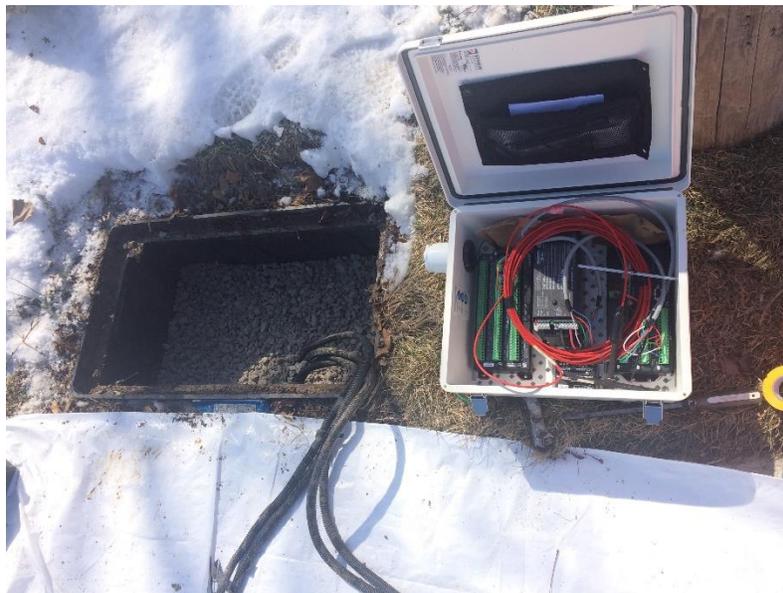
**Figure 4-9 Sub-surface mountbox with instrumentation box and datalogger**

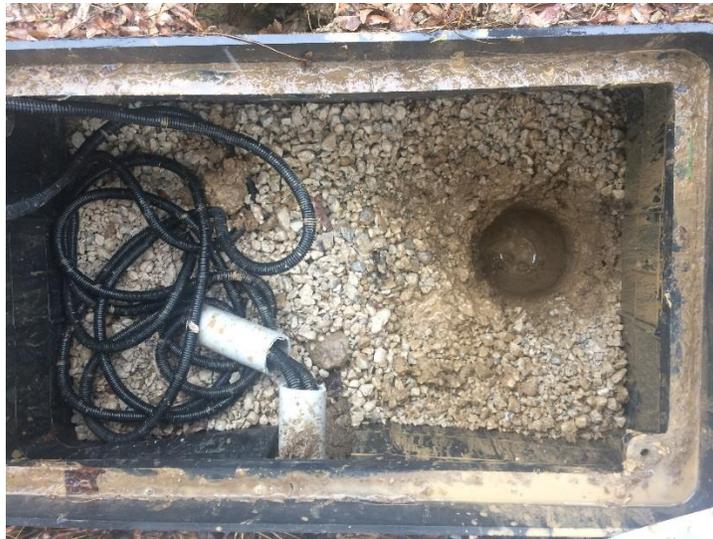
**Figure 4-10 Trench hole and gravel to allow drainage of water – Section 1**

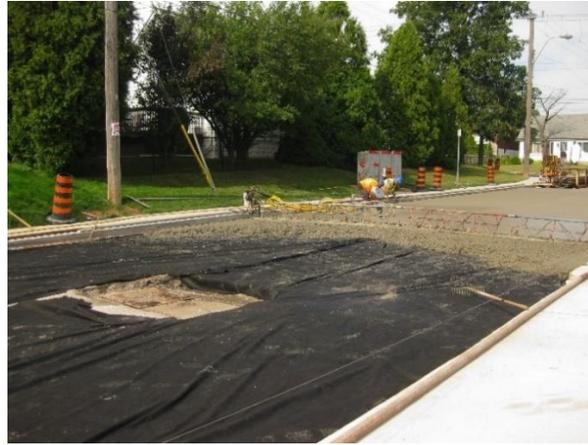
**Figure 4-14 Geotextile cutout for manholes and catchbasins**

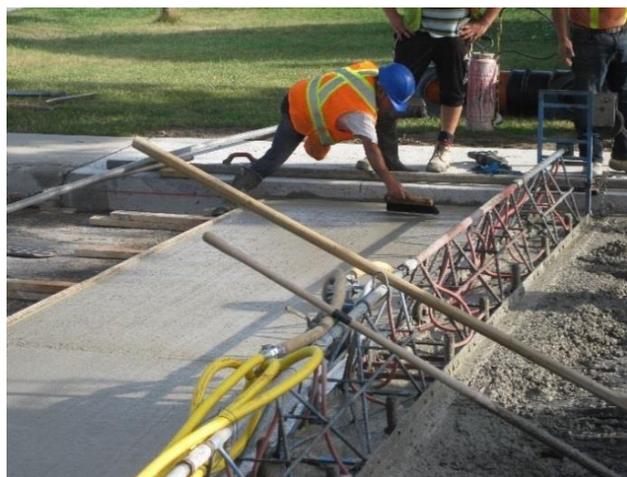
**Figure 4-15 Razorback horizontal screed and broom finish**

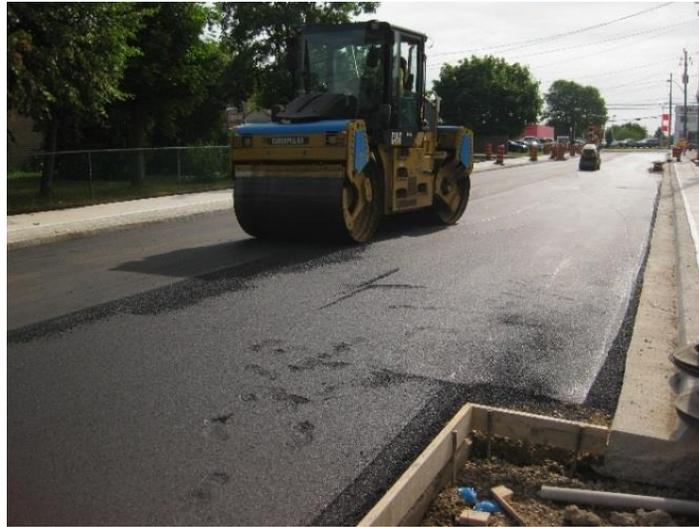
**Figure 4-17 Placement of HMA separation layer**

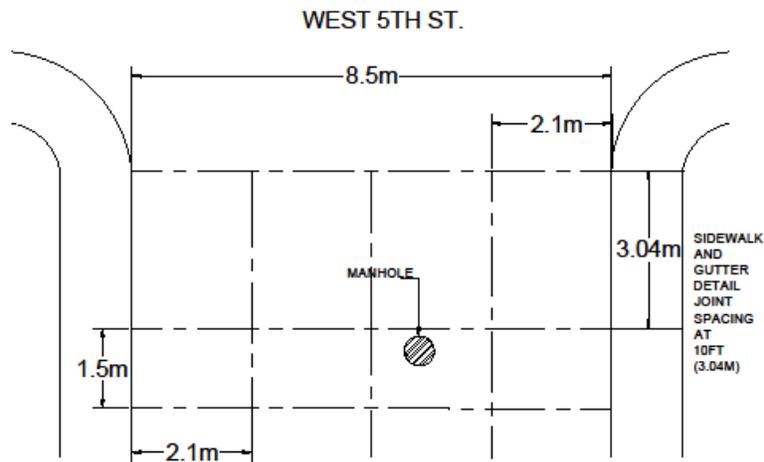
**Figure 4-18 Transverse and longitudinal joint spacing**

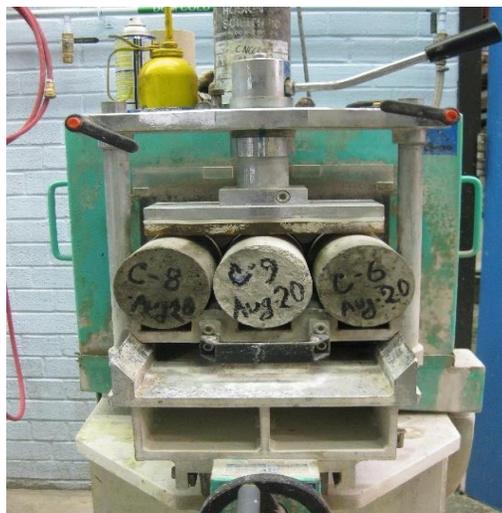
**Figure 4-25 End grinding of concrete cylinders**

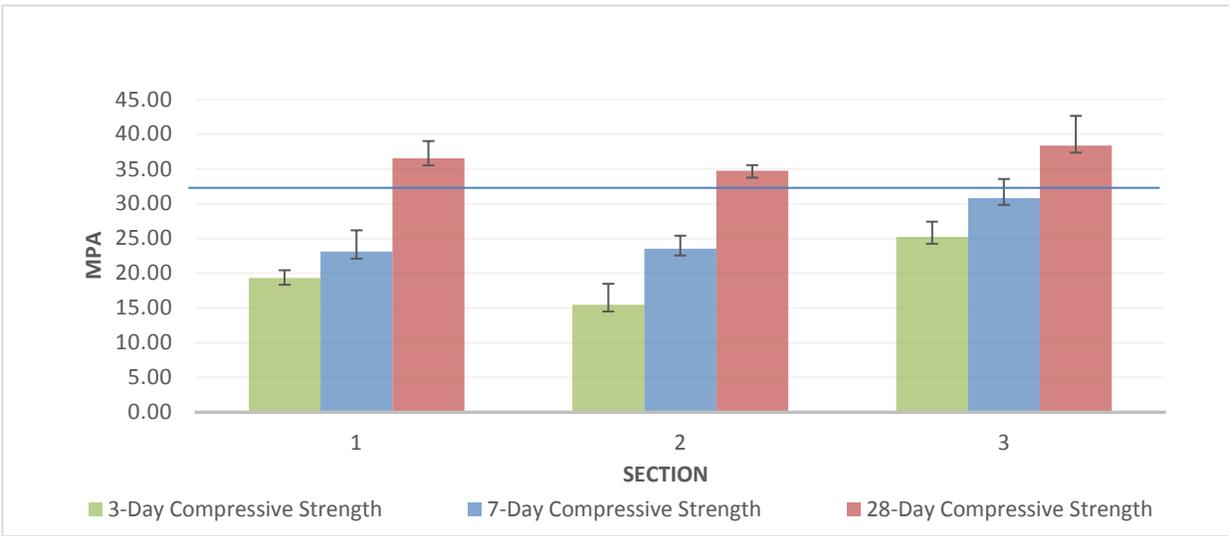
**Figure 4-26 Average compressive strength for Section 1-3**

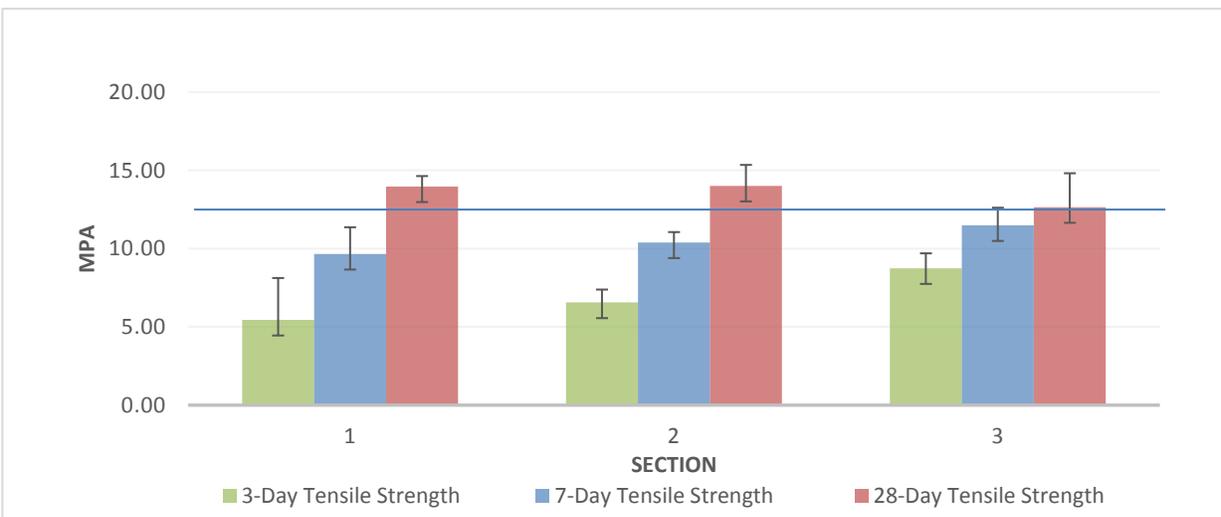
**Figure 4-27 Average in-direct tensile strength for Section 1-3**

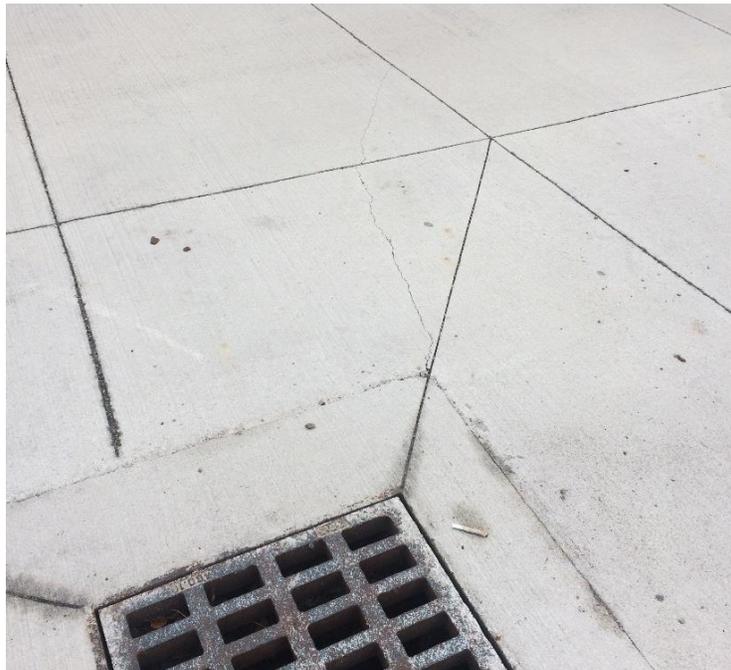
**Figure 4-29 Transverse crack in Section 1 close to catchbasin**

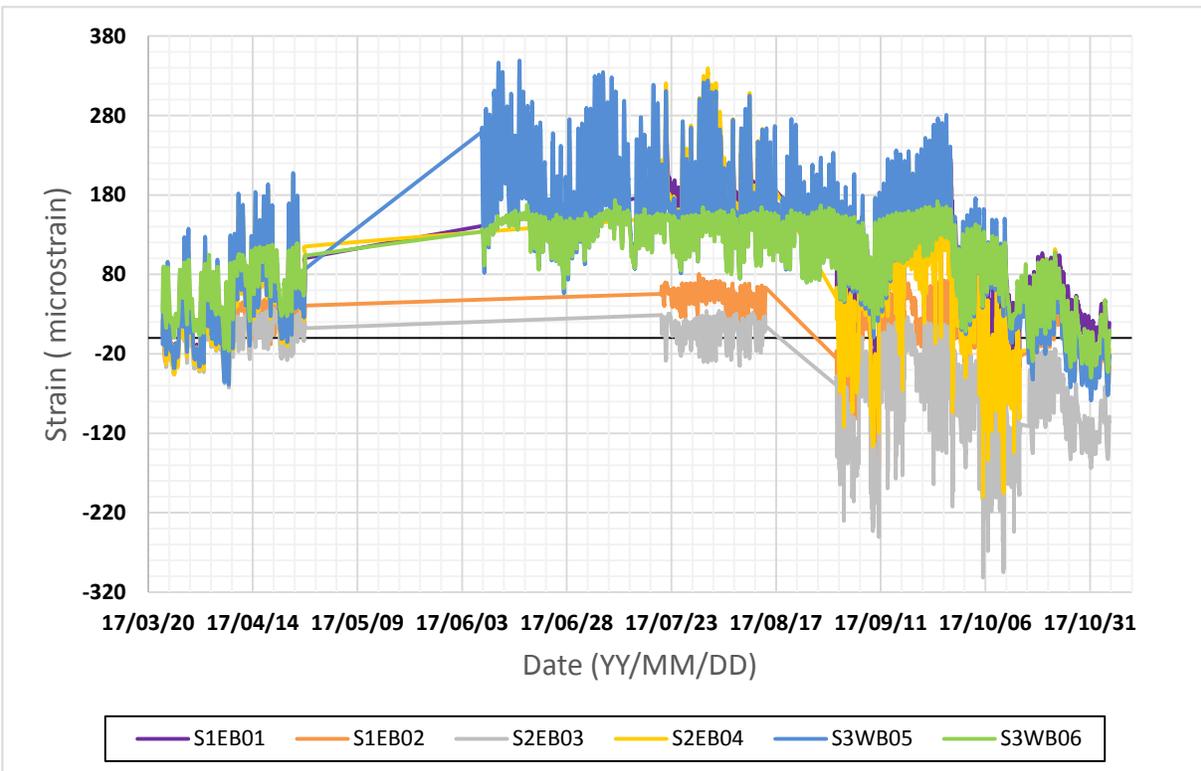
**Figure 5-1 Strain for 6 vibrating strain gauges along Jameston Ave. (March-Nov)**

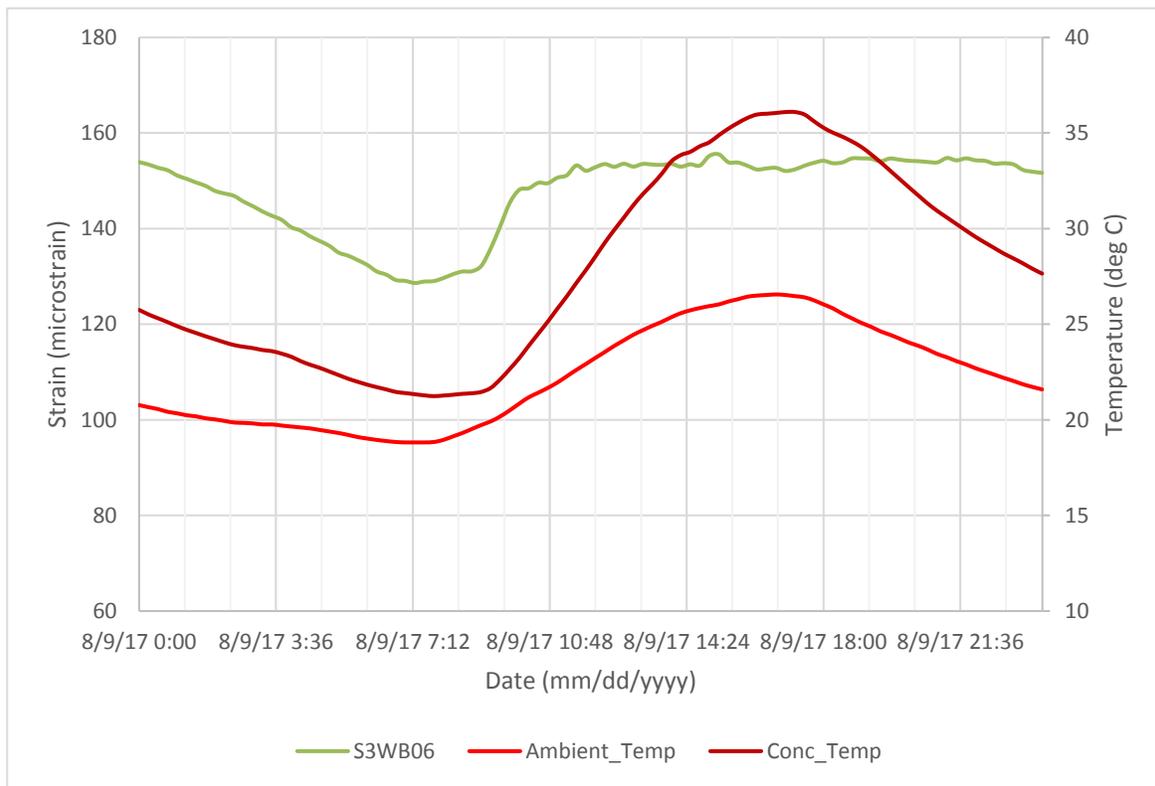
**Figure 5-2 Change in strain vs. temperature for 24 hours (August 9<sup>th</sup>, 17)**

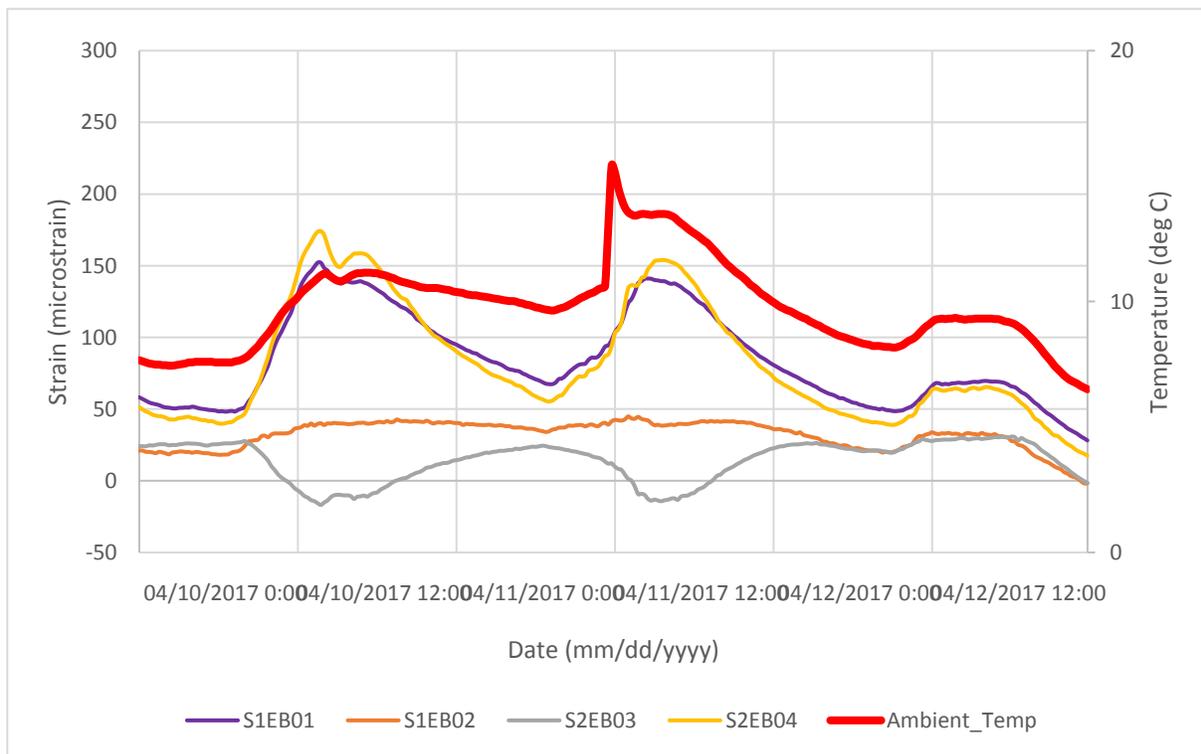
**Figure 5-3 Change in strain vs. ambient temperature – Spring (April 10<sup>th</sup>-12<sup>th</sup> )**

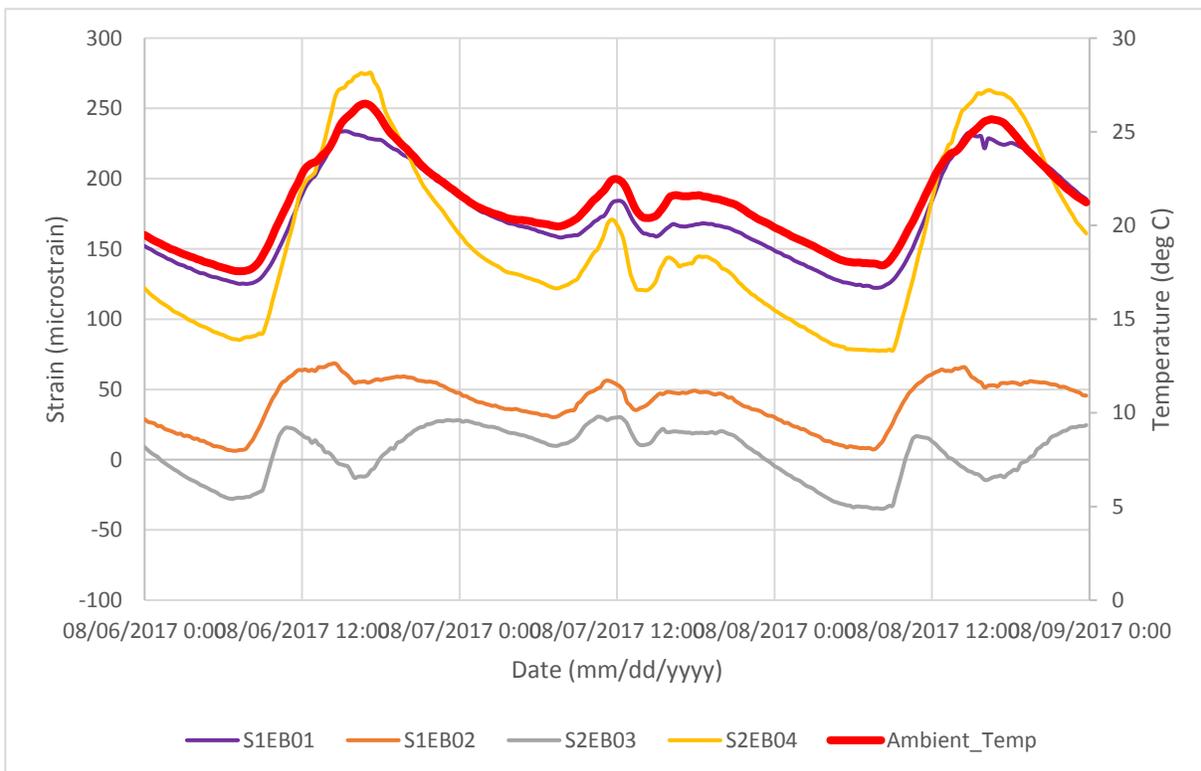
**Figure 5-4 Change in strain vs. ambient temperature – Summer (August 6<sup>th</sup> – 8<sup>th</sup>)**

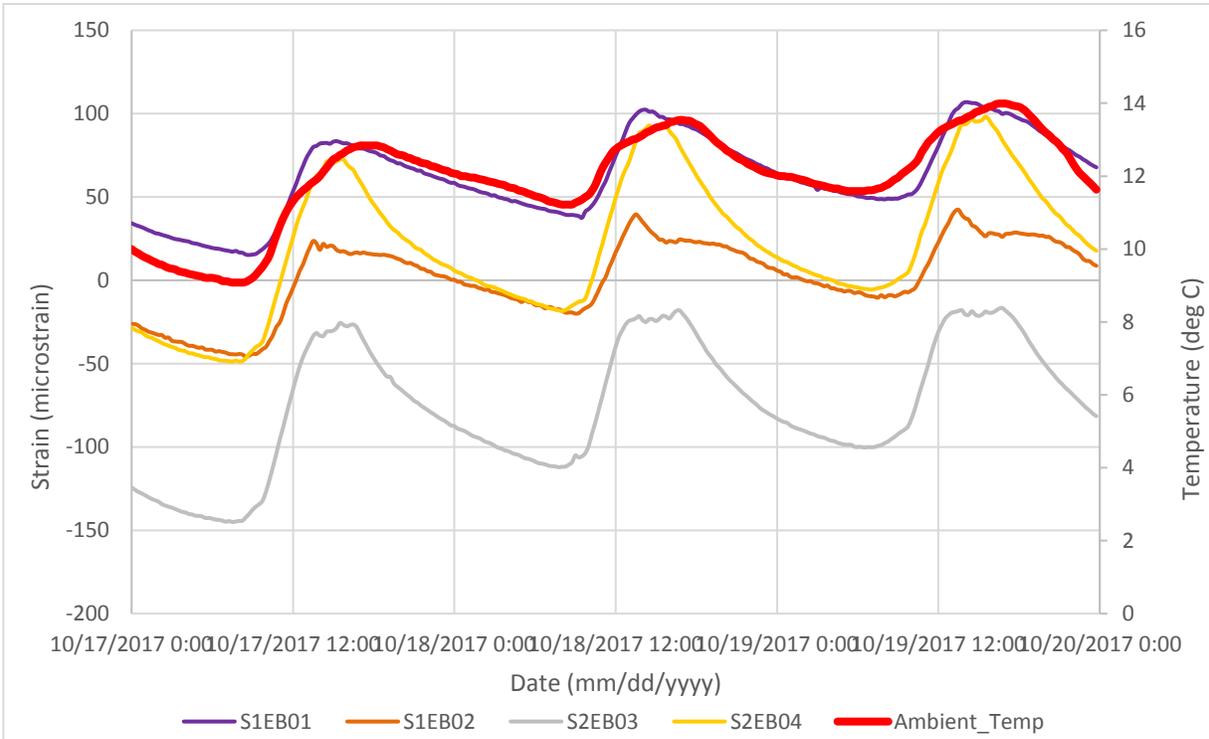
**Figure 5-5 Change in strain vs. ambient temperature – Fall – (October 17<sup>th</sup> -19<sup>th</sup>)**

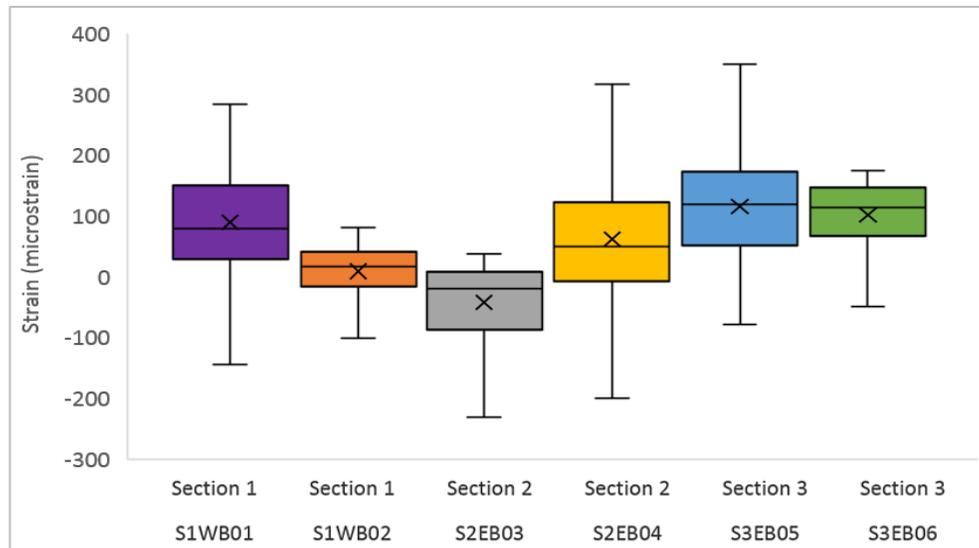
**Figure 5-6 Range of strain on Jameston Ave. for 6 sensors**
