# **Evaluating Unbonded Concrete Overlay for Usage on Ontario Residential Streets**

A thesis  
presented to the University of Waterloo  
in fulfillment of the  
thesis requirement for the degree of  
Master of Applied Science  
in  
Civil Engineering

Waterloo, Ontario, Canada, 2018

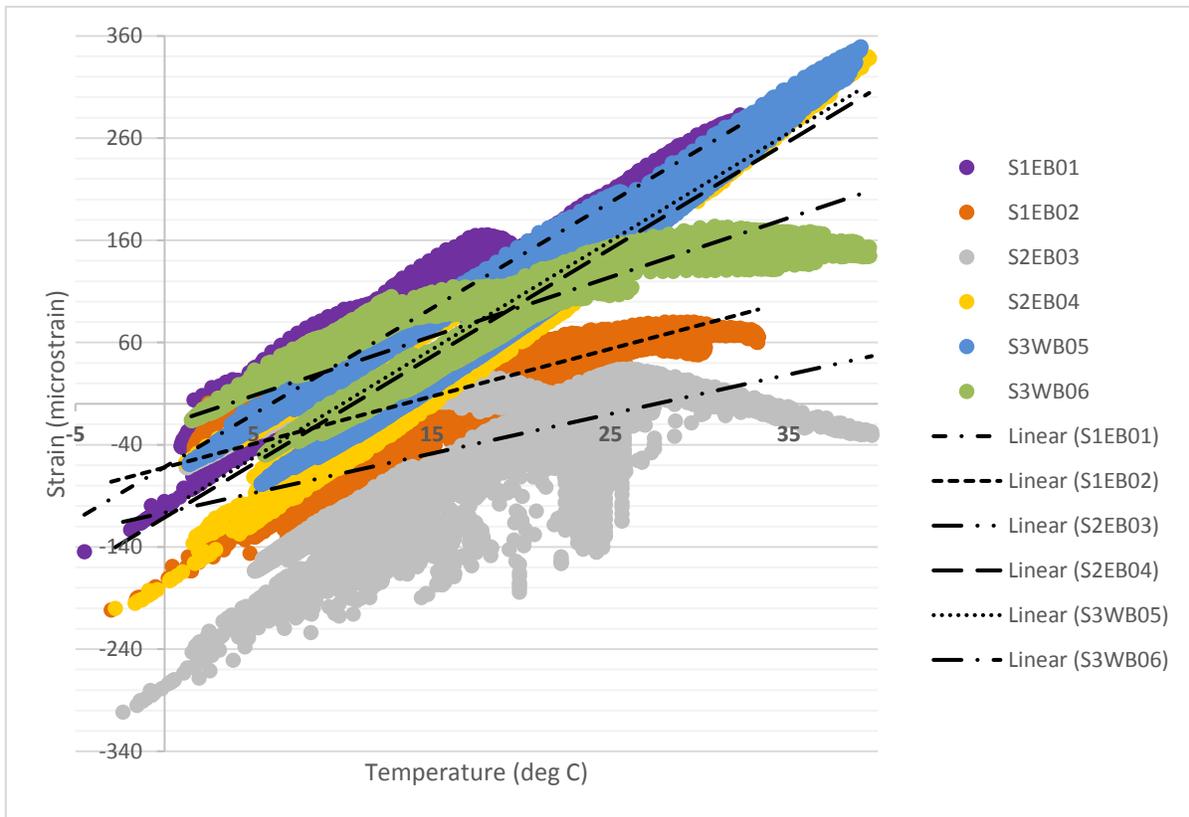
**Figure 5-7 Strain vs. temperature relationship – Jameston Ave.**

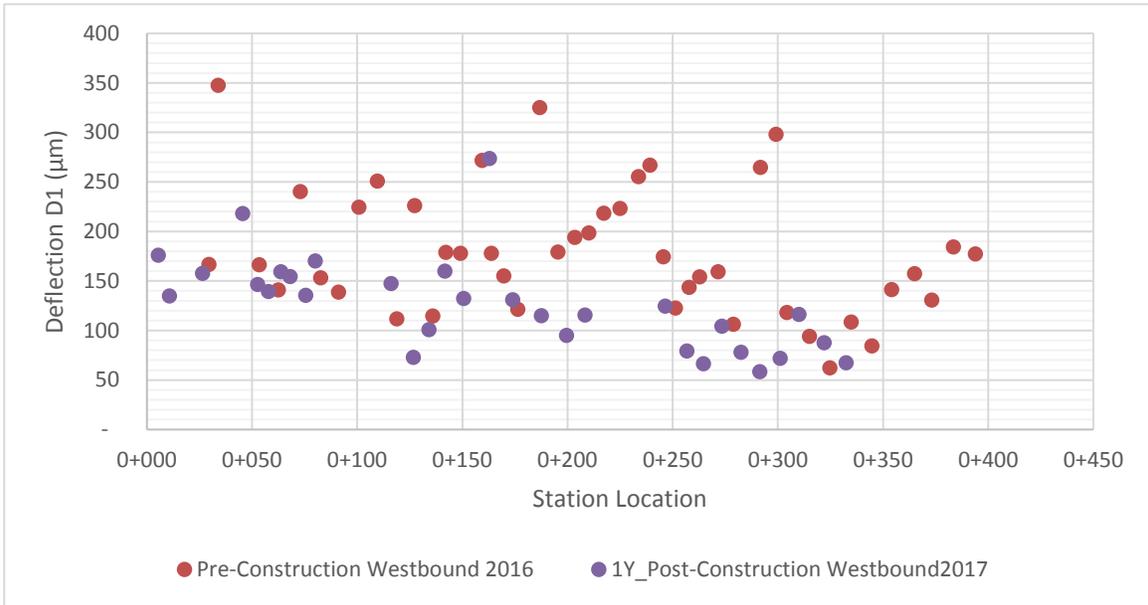
**Figure 5-8 Comparison of maximum normalized deflections (D1) WB-2016 vs.2017**

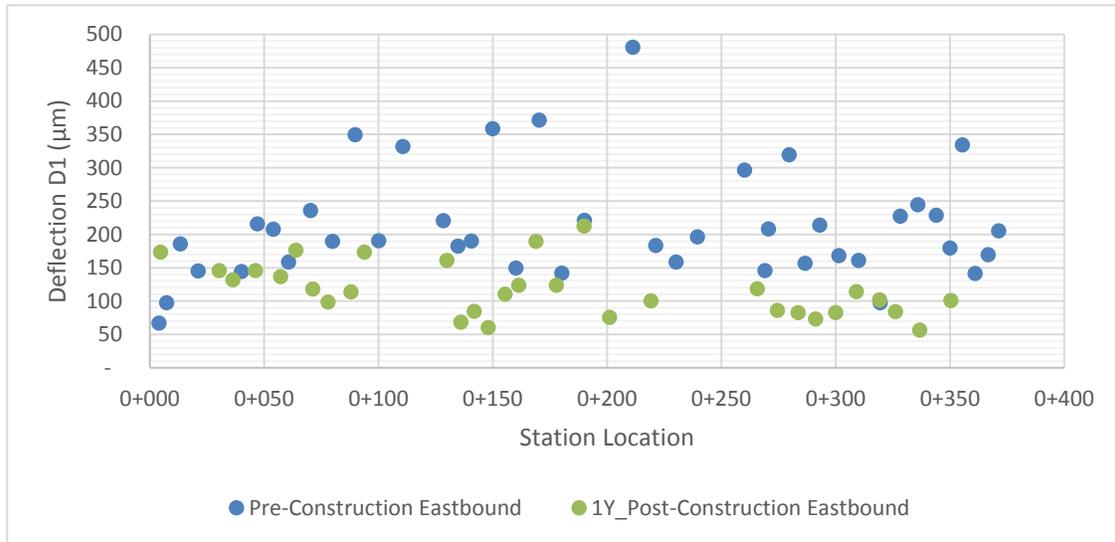
**Figure 5-9 Comparison of maximum normalized deflection (D1) EB – 2016 vs. 2017**

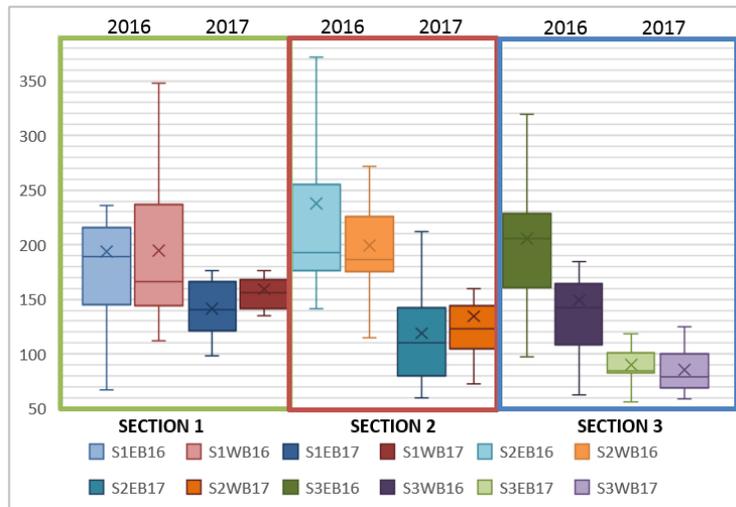
**Figure 5-10 Comparison of maximum normalized deflection for Jameston Ave. (2016 vs. 2017)**

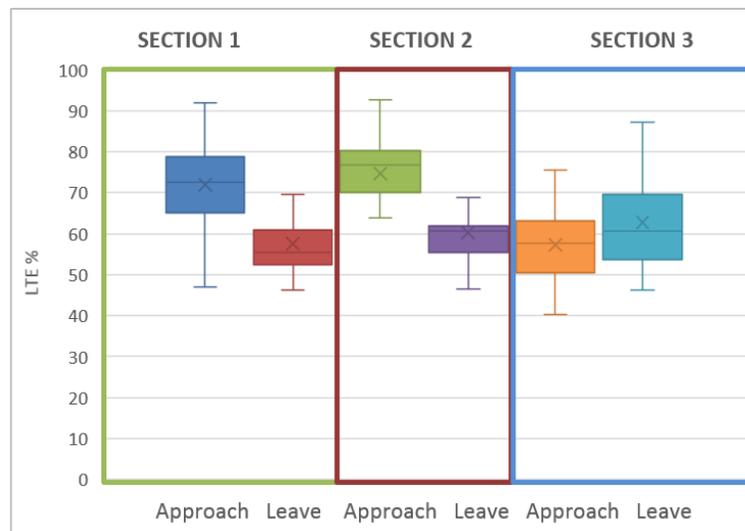
**Figure 5-11 Variability in load transfer efficiency of Jameston Ave. before construction 2016**

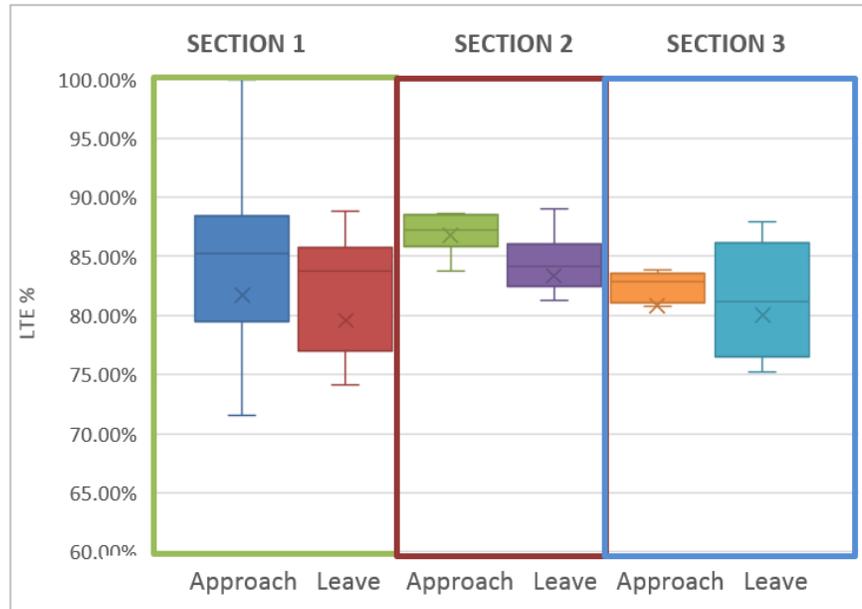
**Figure 5-12 Variability in load transfer efficiency of Jameston Ave. 1Y after construction 2017**

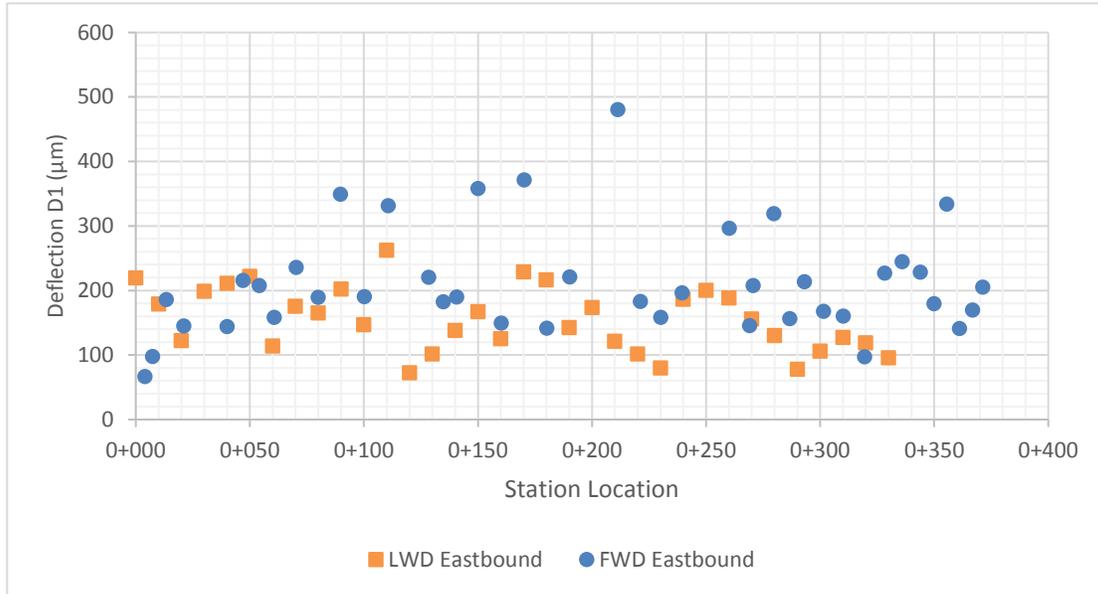
**Figure 5-13 Comparison of normalized deflections (D1) for LWD and FWD pre-construction**

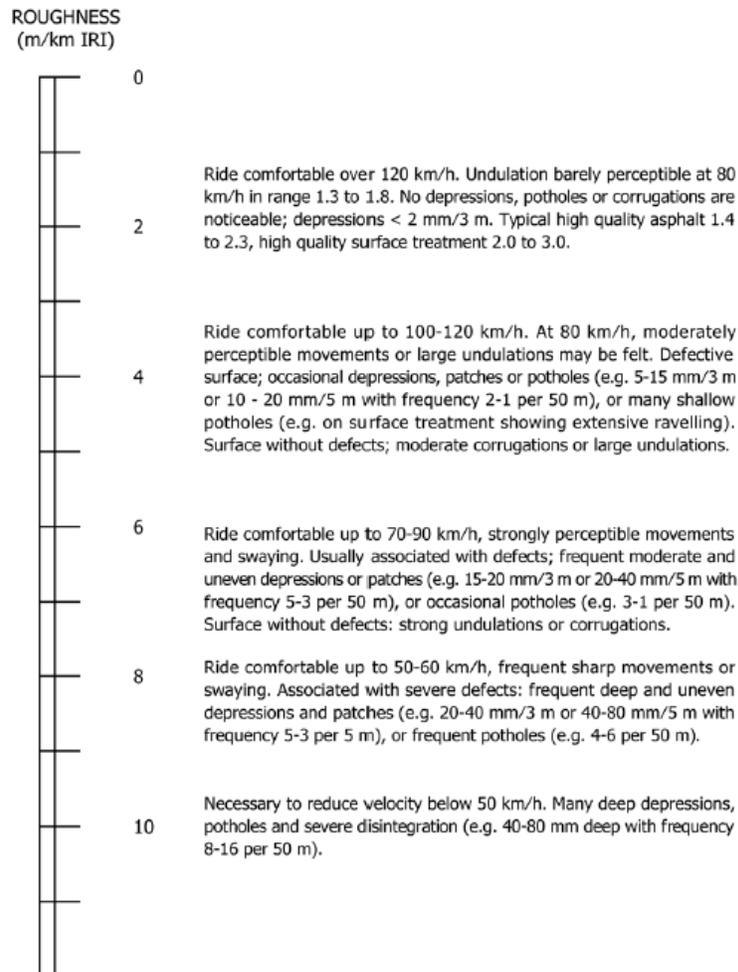
**Figure 5-15 Road roughness estimation scale for paved roads with asphaltic concrete or surface treatment (ASTM International, 2008)**

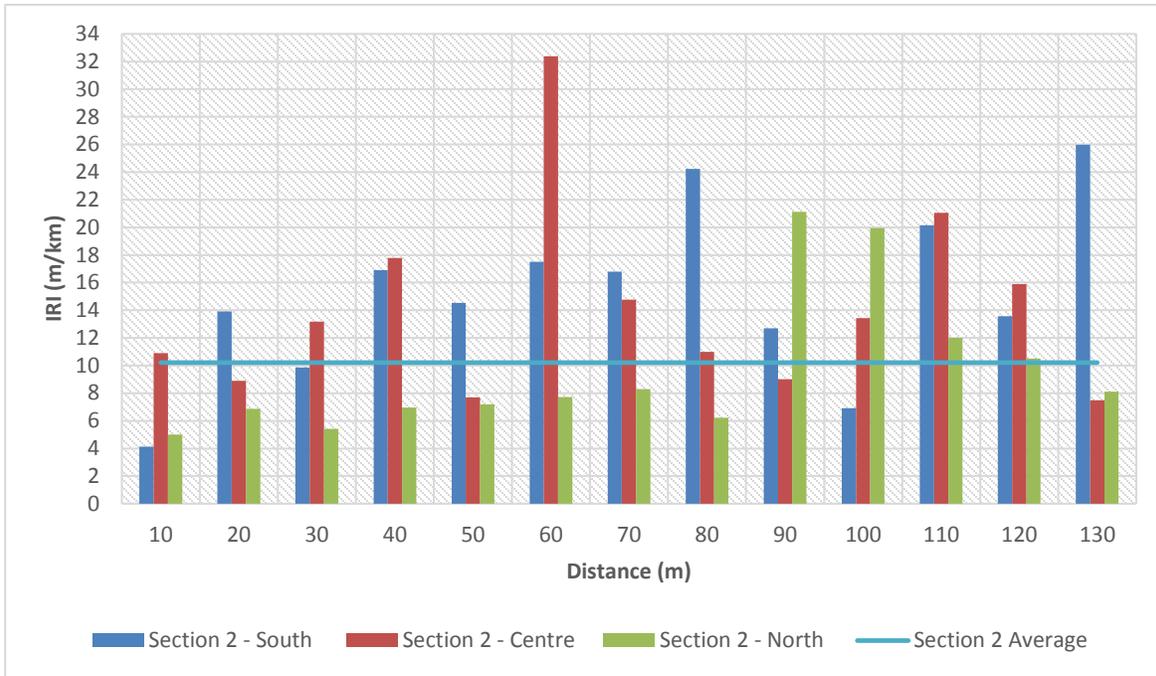
**Figure 5-16 Section 2 IRI existing concrete before construction**

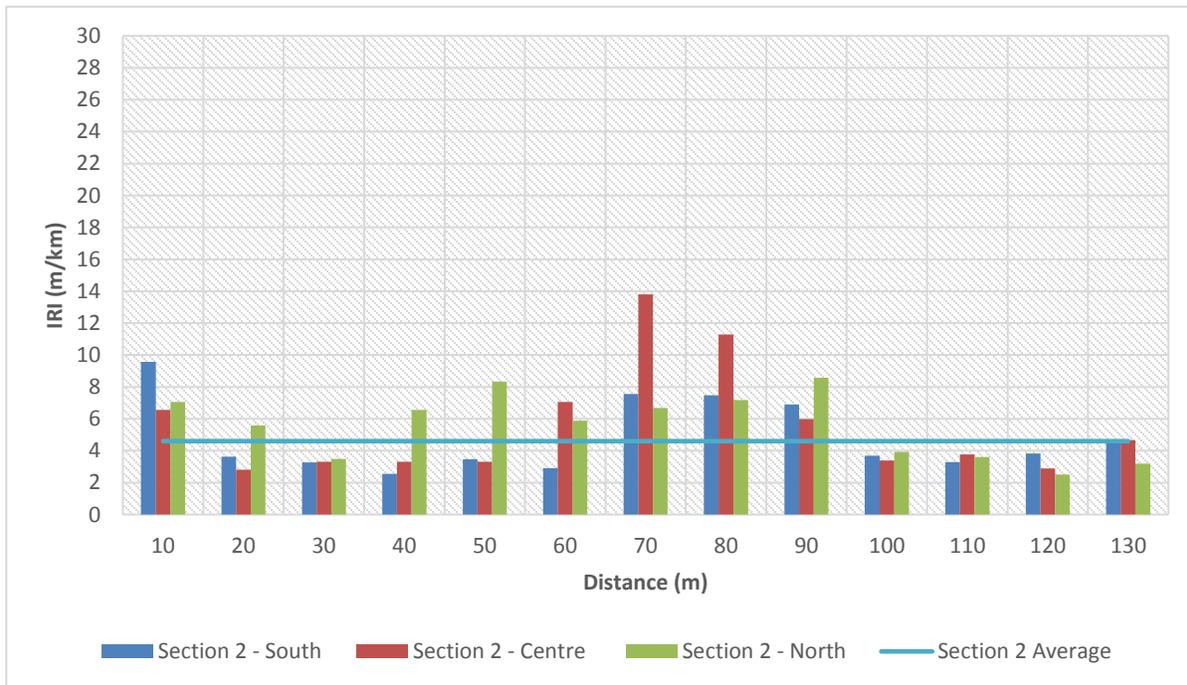
**Figure 5-17 Section 2 IRI new concrete before opening road**

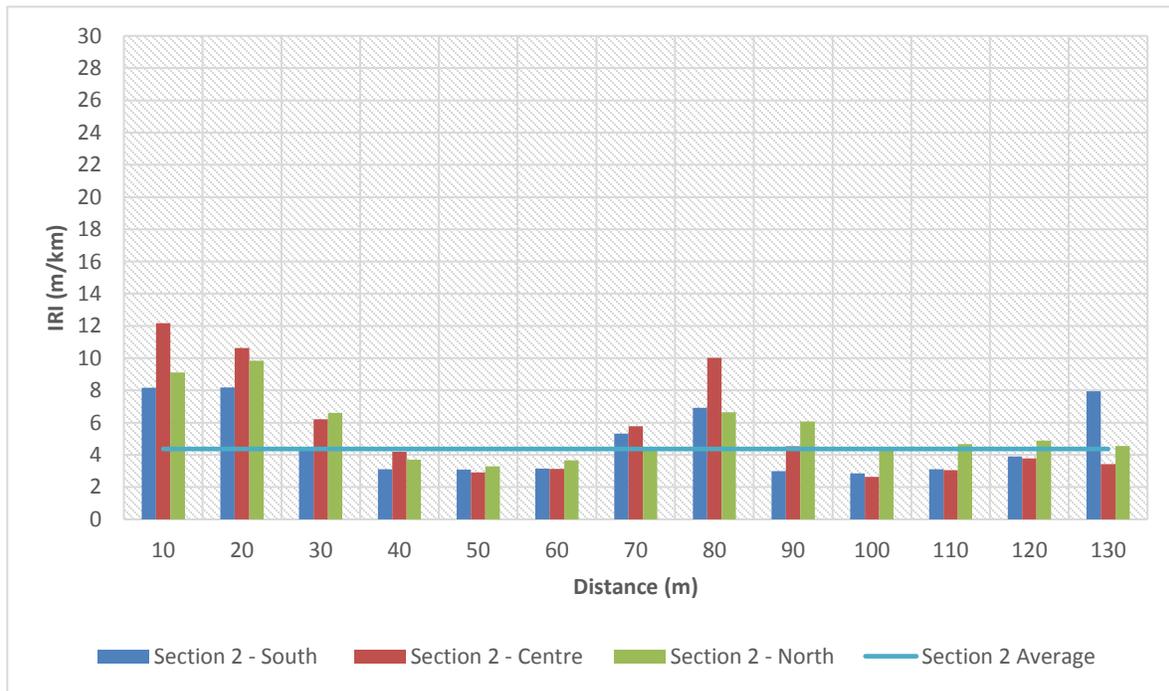
**Figure 5-18 Section 2 IRI concrete overlay after 1Y of traffic**

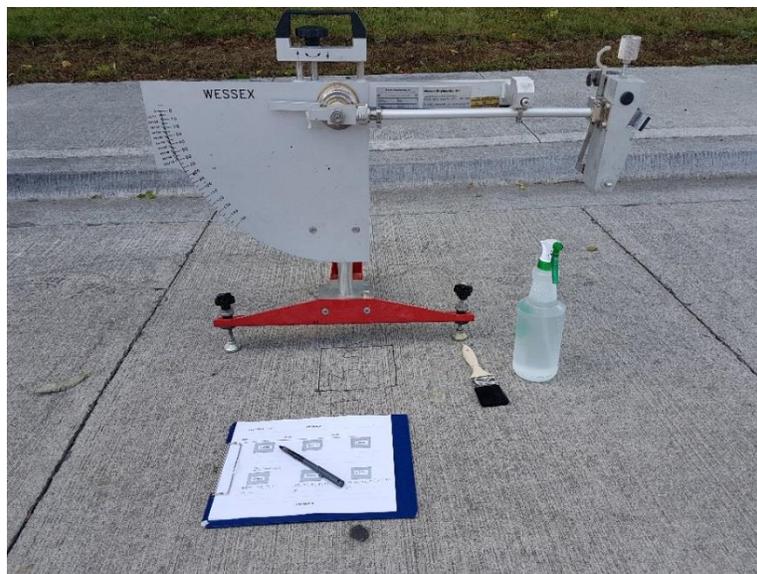
**Figure 5-19 British Pendulum Test Apparatus**

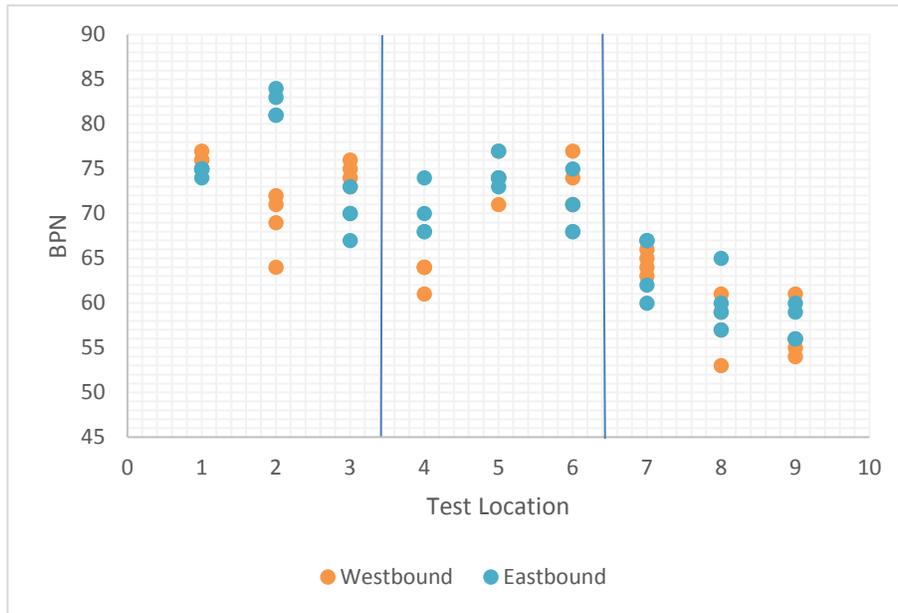
**Figure 5-22 British Pendulum results for 1Y old Jameston Ave.**

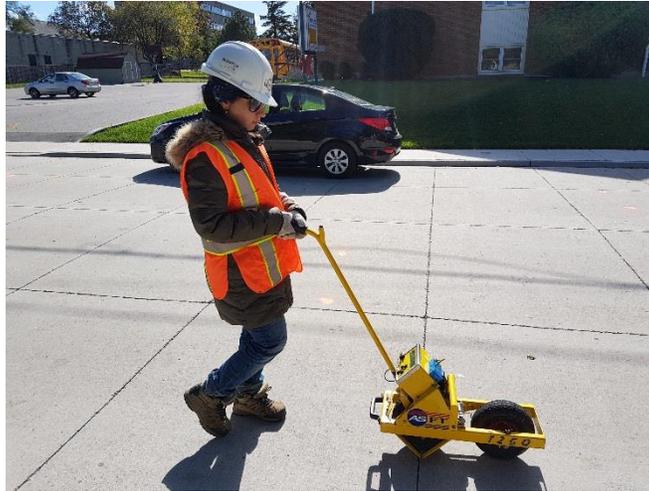
**Figure 5-23 T2GO testing on Jameston Ave. concrete overlay**

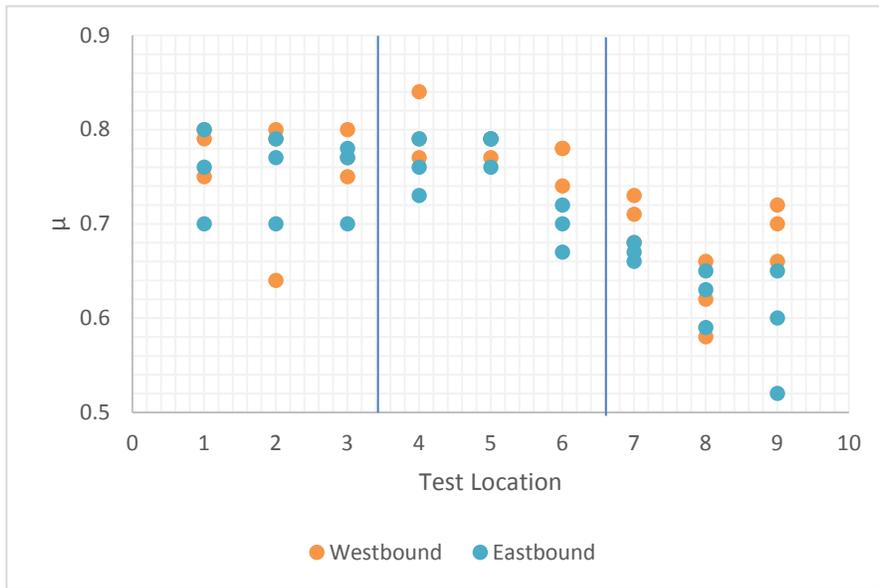
**Figure 5-24 T2GO results for newly constructed Jameston Ave.**

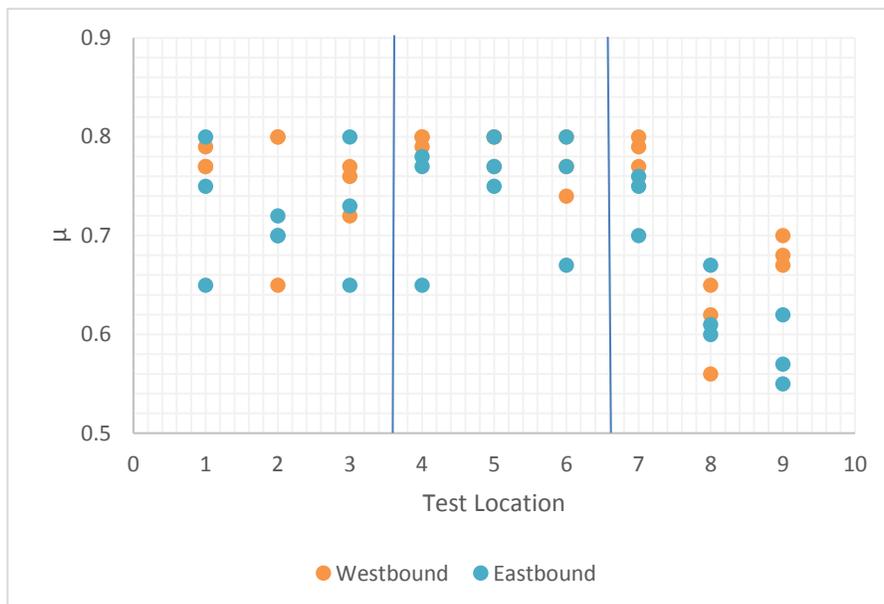
**Figure 5-25 T2GO results for 1Y old Jameston Ave.**

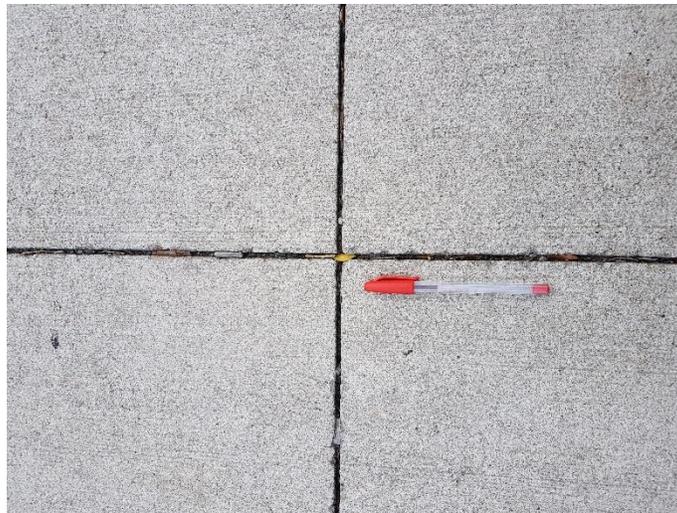
**Figure 5-26 Typical Joint in Section 1 – 1Y after construction**

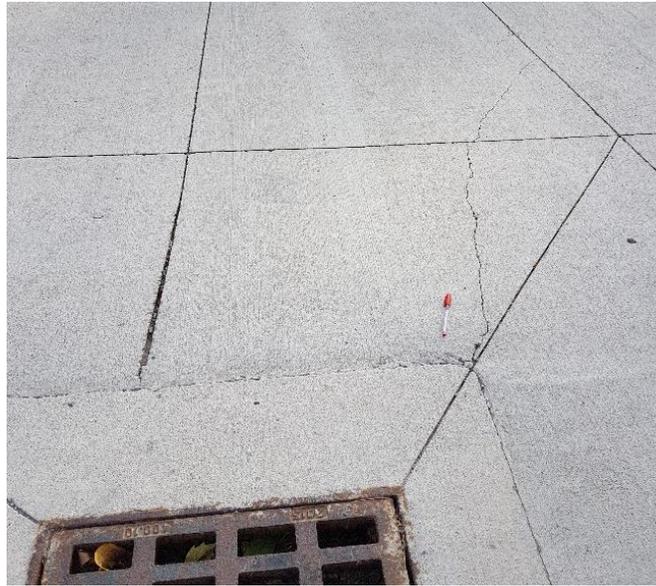
**Figure 5-27 Moderate transverse crack – Section 1**

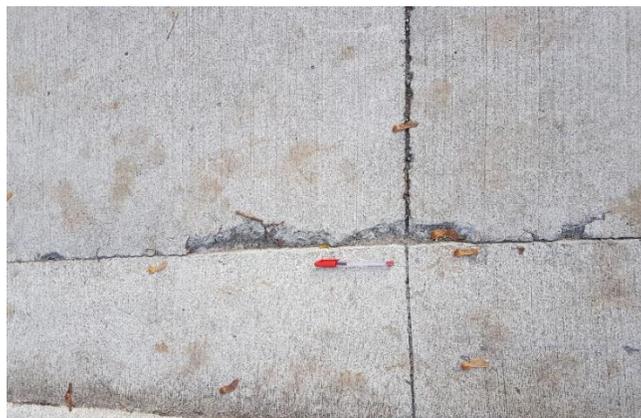
**Figure 5-28 Moderate longitudinal joint spalling – Section 2 – 1Y after construction**

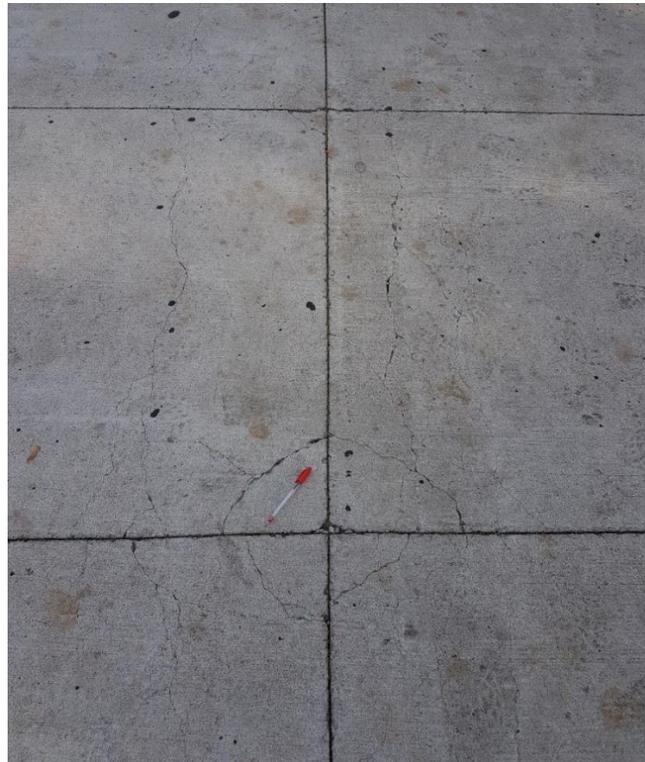
**Figure 5-29 Moderate d-cracking in Section 2 – 1Y after construction**

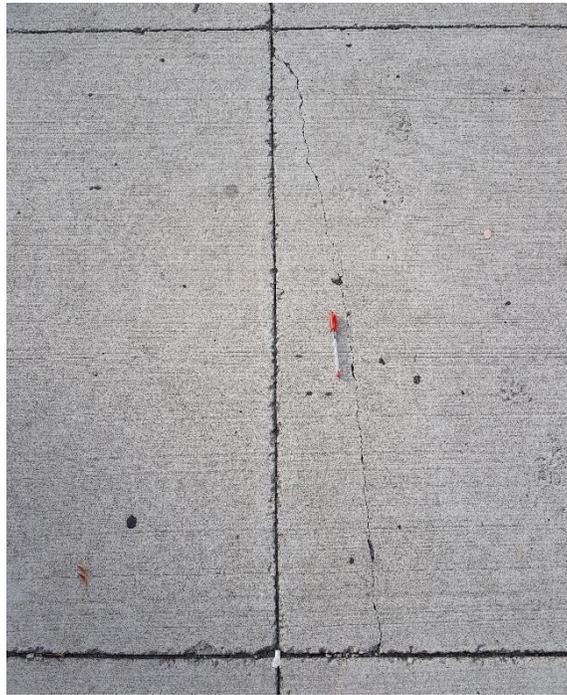
**Figure 5-30 Moderate longitudinal crack – Section 2 – 1Y after construction**

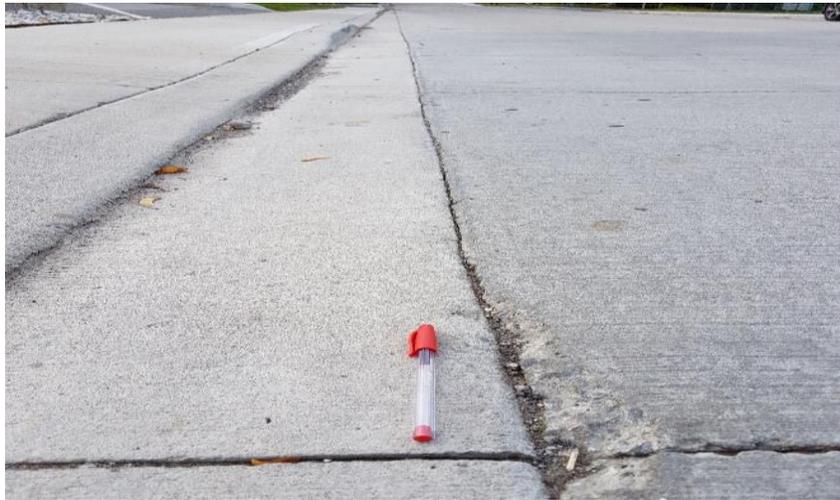
**Figure 5-31 Moderate longitudinal joint spalling – Section 3 – 1Y after construction**

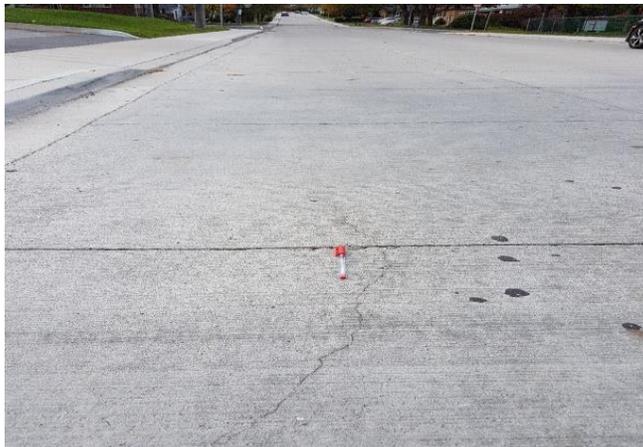
**Figure 5-32 Longitudinal cracking with slight meandering – Section 3 – 1Y after construction**

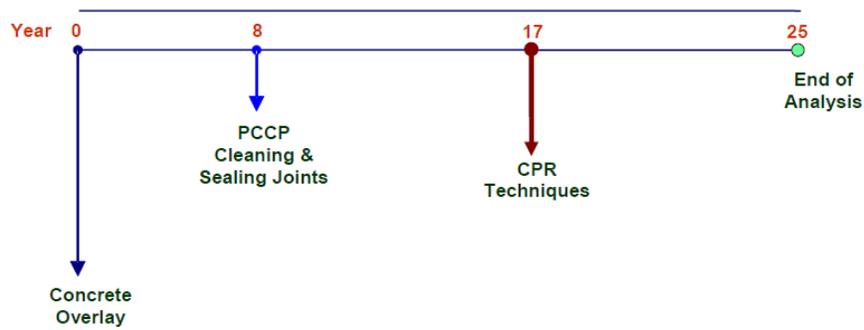
**Figure 5-33 Time-based alternative for existing composite pavement – concrete overlay (Lampthey, et al., 2005)**

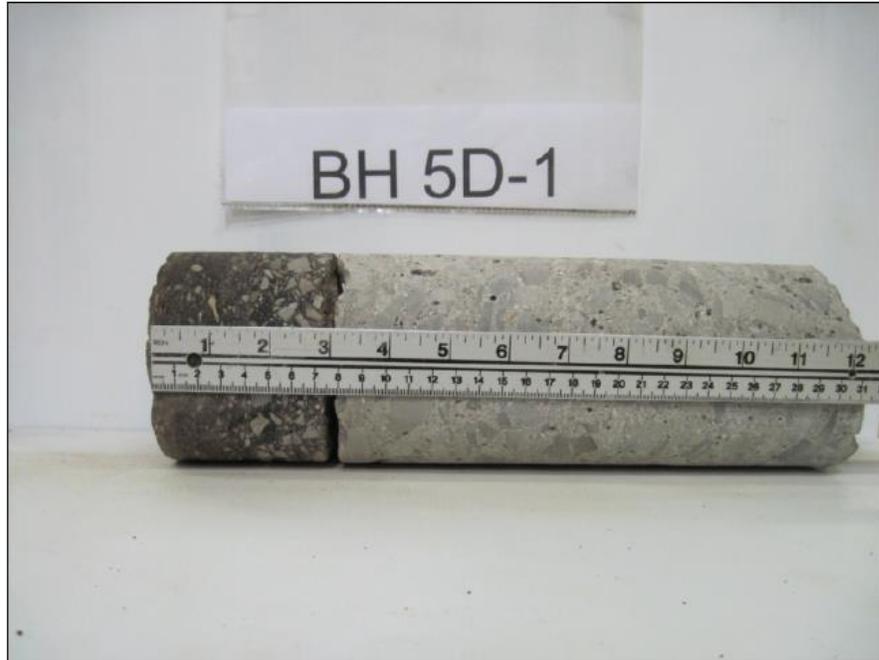
BH 5D-1, DEPTH 0 - 310 mm

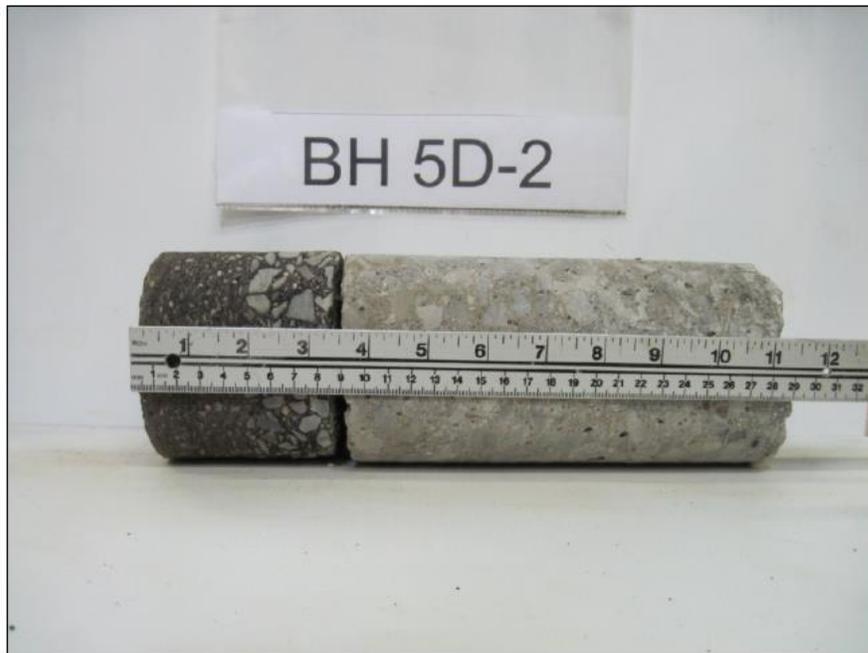
BH 5D-2, DEPTH 0 - 290 mm

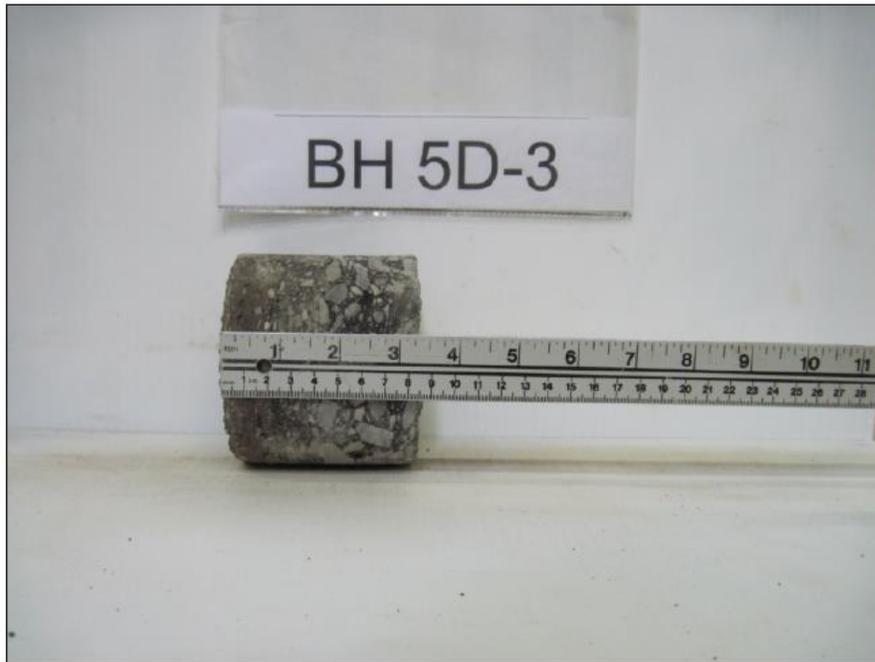
BH 5D-3, DEPTH 0 - 80 mm

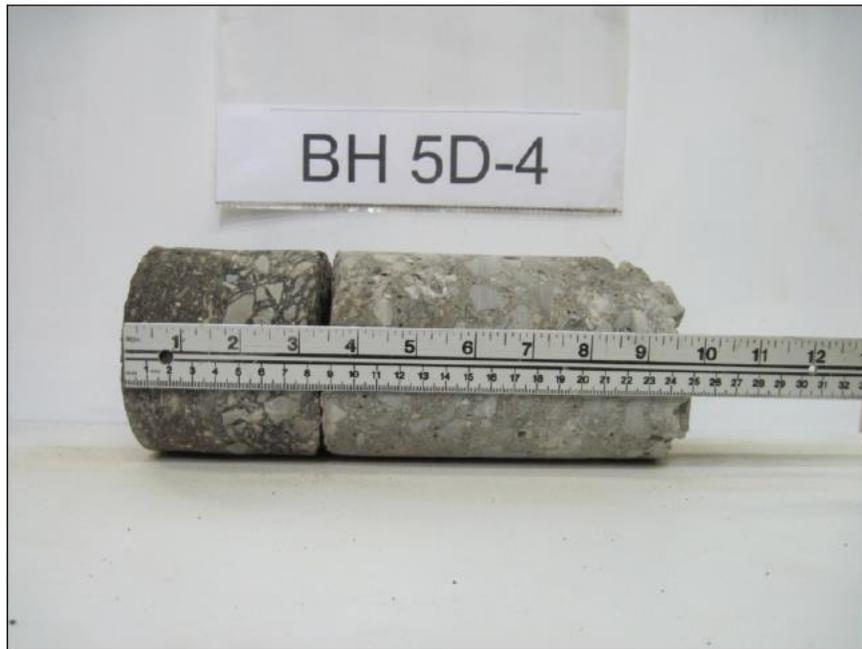
BH 5D-4, DEPTH 0 - 250 mm
