**TEN YEAR PERFORMANCE EVALUATION OF UNBONDED
CONCRETE OVERLAY AND JOINTED PLAIN CONCRETE
PAVEMENT: A TORONTO CASE STUDY**

Paper prepared for presentation at the
“Urban Pavements - Better, Safer, Faster” session
of the 2013 Conference of the
Transportation Association of Canada
Winnipeg, Manitoba

This paper presents an overview of the existing conditions, design, construction and instrumentation of the Bloor and Aukland site and a ten year performance evaluation of the rehabilitated pavements.

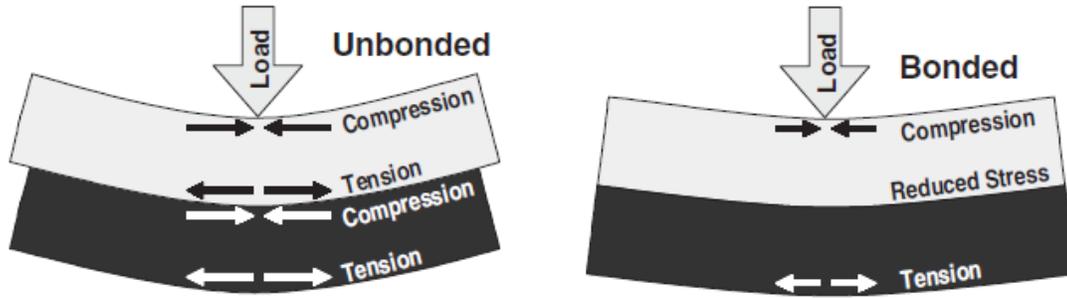
FIGURE 6 Comparison of unbonded and bonded overlay strain profiles (11)

The trend of increasing compression at the top surface is no surprise; however, the bottom sensors are expected to be measuring tensile strains. Unbonded overlays are designed to have the overlay slab and existing slab bend separately under traffic and environmental loads due to the placement of a separation layer, shown in Figure 6.

However, preventing a bond between the two concrete layers cannot always be accomplished. It is possible that this may be the case with the Bloor Street overlay. The evidence of compressive strains throughout the thickness of the overlay may indicate that both slabs (old and new) are behaving monolithically and that the neutral axis falls in the old slab. The bonding of the layers can add additional structural capacity to the pavement, but is generally undesirable because it may allow reflective cracking to occur (6). By and large, the strains measured in the overlay section remain fairly low, i.e. well below cracking thresholds. The threshold for flexural (tensile) crack formation in a 30 MPa concrete is approximately 130 microstrain (12). Consequently, considerable remaining pavement service life is expected.
